CHAPTER TWELVE

PERIOD 3—AFTER THE EARTHQUAKE

AREA A (Fig. 128)

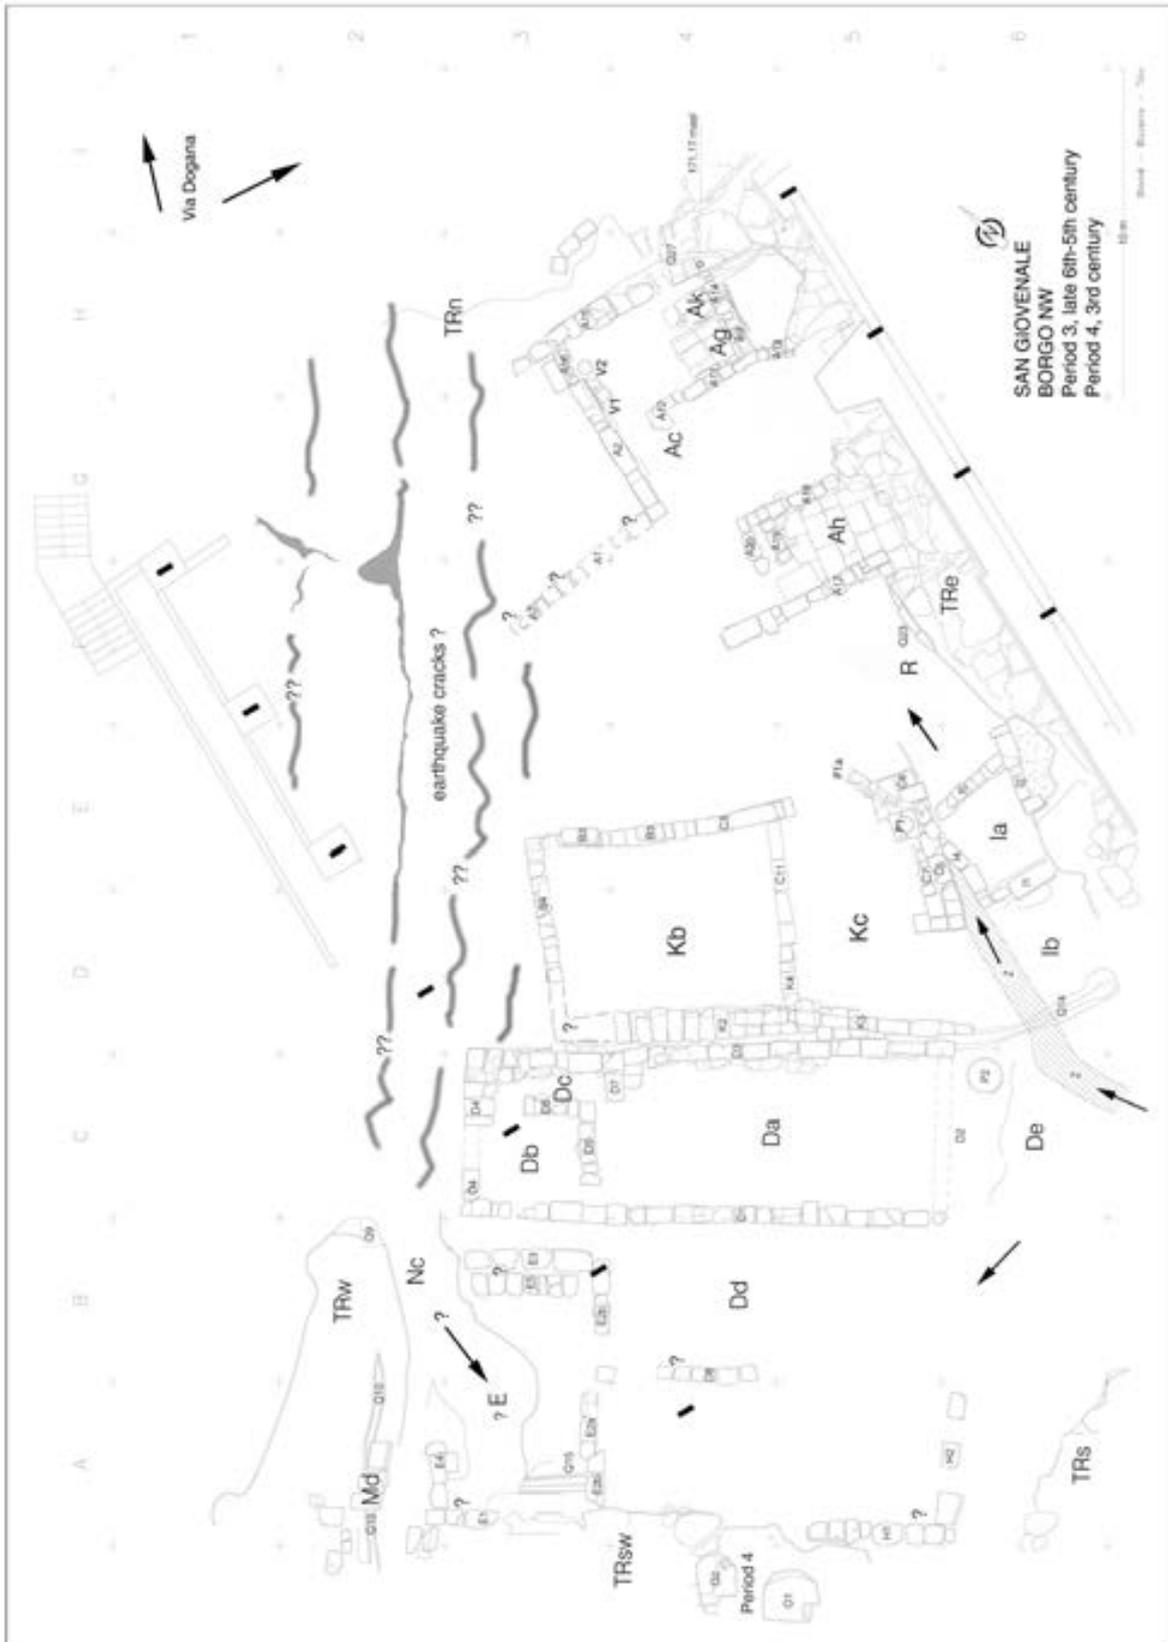
Fig. 128. Plan of Periods 3 and 4.

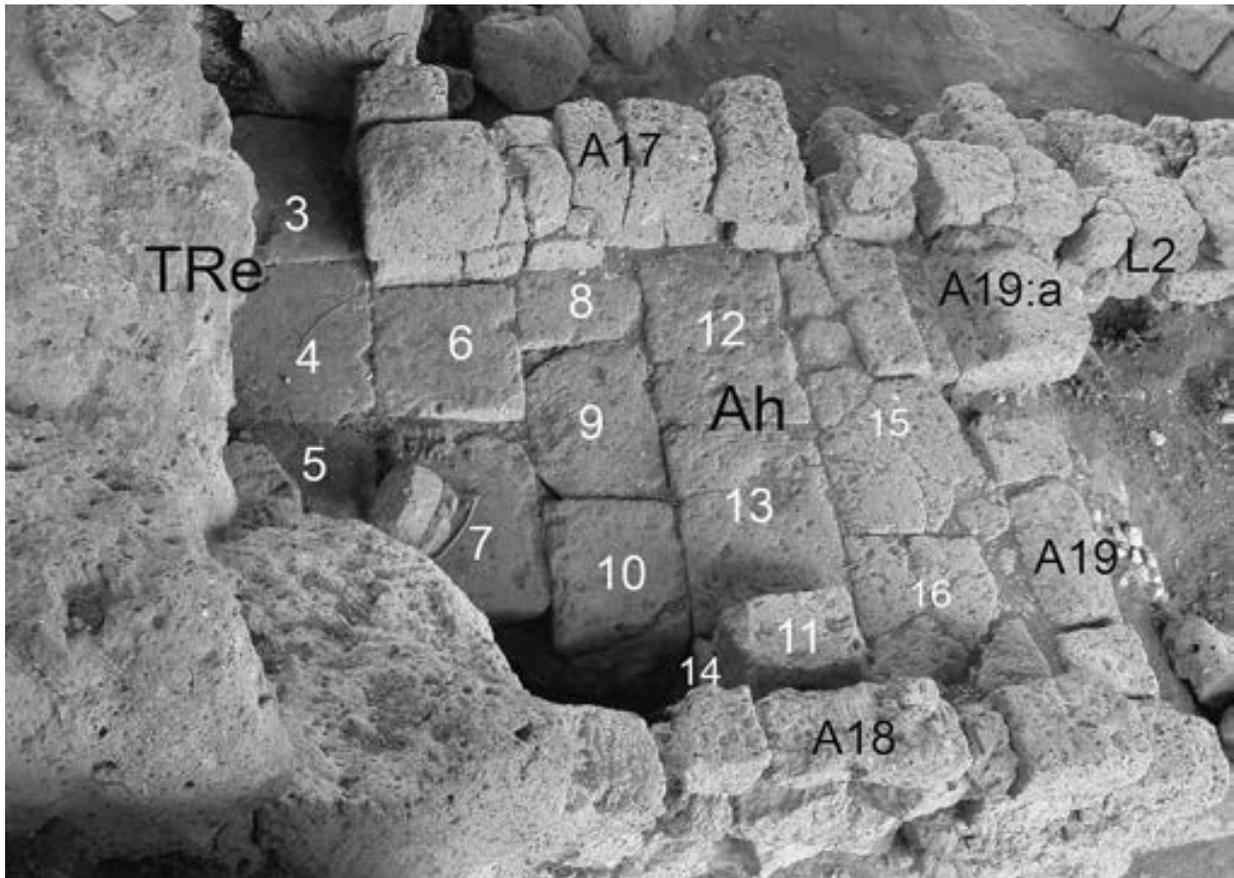
Fig. 129. Niche Ah3 with new pavement blocks from the north.

The Ah3 pavement was clearly laid from the south with Drain wall L2 as the point of departure. The blocks, mostly huge and very well cut, are laid closely to it while on the opposite side they make an irregular, partly earth-filled edge against the sloppily built wall A18. In addition, at a certain point the pavement blocks 15–21 are re-oriented with a change of direction.

Measurements of pavement blocks (Fig. 129)

(1) $0.96 \times 0.70 \times 0.24$ m; (2) 0.90×0.60 m; (3) $0.91/0.81 \times 0.65 \times 0.24$ m; (4) 0.87×0.66 m; (5) 0.90×0.65 m; (6) 0.68×0.63 m; (7) 0.93×0.64 m; (8) 0.43×0.57 m; (9) 0.82×0.56 m; (10) 0.63×0.54 m; (11) 0.38×0.54 m; (12) 1×0.66 m; (13) 1×0.66 m; (14) 0.42×0.64 m; (15) $0.65 \times 0.20/0.26$ m; (16) $0.89 \times 0.60/76 \times 0.18$ m; (17) $0.76 \times 0.60/0.77$ m; (18) $0.82/0.76 \times 1.20/1.13$ m; (19) $0.30 \times 0.38 \times 0.29$ m; (20) $0.69 \times 0.40 \times 0.28$ m; (21) $0.22 \times 0.45 \times 0.30$ m (the third measurement on some blocks refers to the thickness). The huge block 18 clearly had a particular function as indicated by a canal-like cutting in a north–south direction. In front of blocks 18–21 there was apparently a narrow gap and then a further row of four stones, one as part of wall A18 and the other three less carefully shaped.

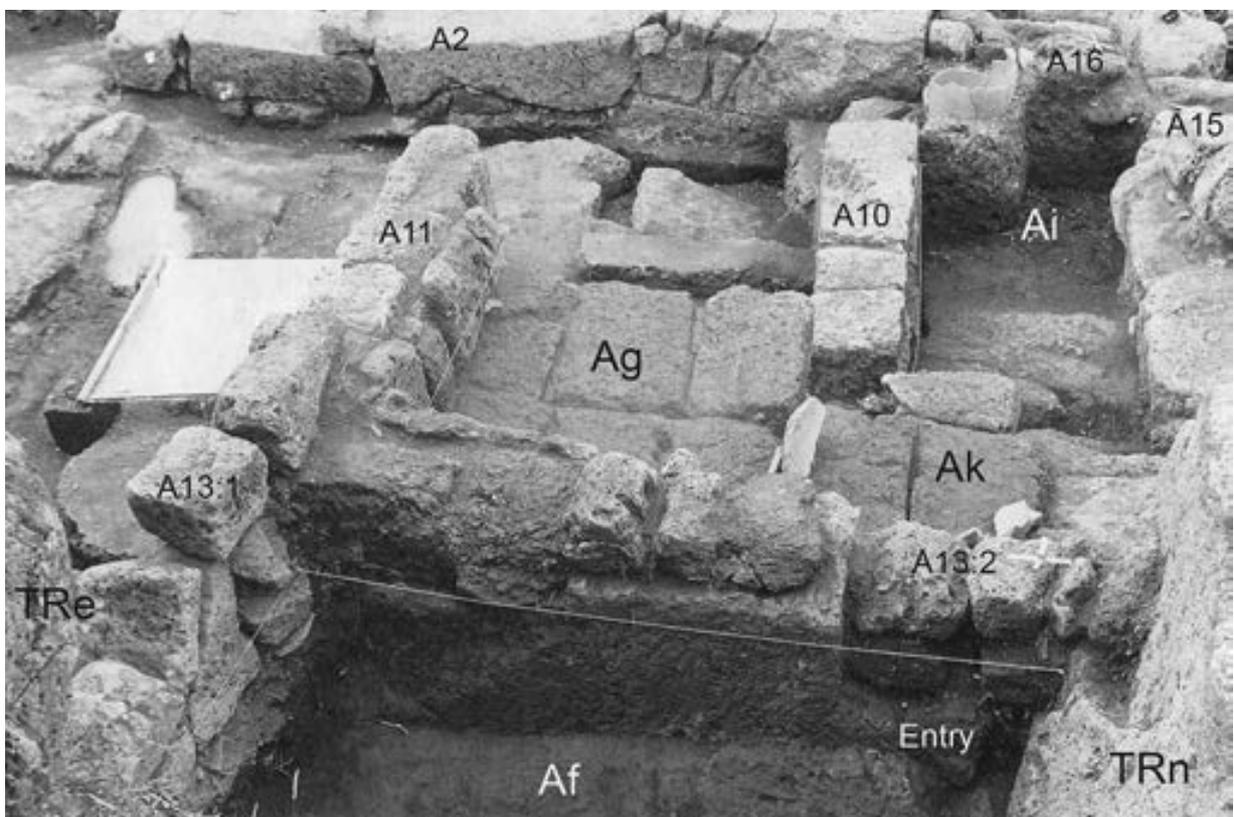
Fig. 130. Niches Ag and Ak from the east.

Niche Ag (Figs. 130–131)

The carefully built, niche-like construction Ag looks like a smaller version of Ah, limited on three sides by low walls, some 0.50–0.60 m high, and open at the front, towards the west. The six blocks of its pavement rest on the fill in the former room Ac at a level *uf.* 1.67 m and its upper, pavement level is on *uf.* 1.27 m. It is built against the pre-existing walls A11 and A9, and a ledge, *c.* 0.03 m high and 0.12–0.15 m wide, along its northern side indicates the former existence of thin, vertical slabs constituting its demarcation against the north and niche Ak. Such thin, vertical slabs are still preserved on the eastern and southern sides leaning against walls A9 and A11.

(1) 0.85×0.45 m; (2) 0.85×0.45 m; (3) 0.85×0.45 m; (4) $0.80 \times 0.44 \times 0.37$ m; (5) $0.80 \times 0.49 \times 0.37$ m; (6) $0.83 \times 0.45 \times 0.37$ m (the third measurement on some blocks refers to the thickness). Side walls: thin, vertical slabs of varying lengths: 0.20, 0.36, 0.40, 0.55 and 0.80 m, *c.* 0.57 m high and 0.11–0.14 m wide.

This construction, connected/related with Ag and with a clear hearth function, was built in the extension of the former wall A10 of room Ac and rests partly on some fill, partly on the rising tufa rock. It now consists of two pavement-like blocks; there is some indication, however, that there may have been two more blocks in front of the present ones. Its upper, pavement level is identical with that of Ag (*uf.* 1.26/1.27 m) and the two were, quite obviously, related, using the vertical slabs of Ag as a joint demarcation. At the back, towards east, it leans, in part, on the rock-cut wall A9 of the former room Ac and, in part, of the now blocked entrance to rock niche Af behind it to the east.

Hearth construction Ak presently consists of only two blocks: (1) $0.96 \times 0.45 \times 0.20$ m; (2) (fragmentary) $0.96 \times 0.45 \times 0.20$ m. On its upper surface there was a hearth consisting of broken tiles and big fragments of broken *dolia*.

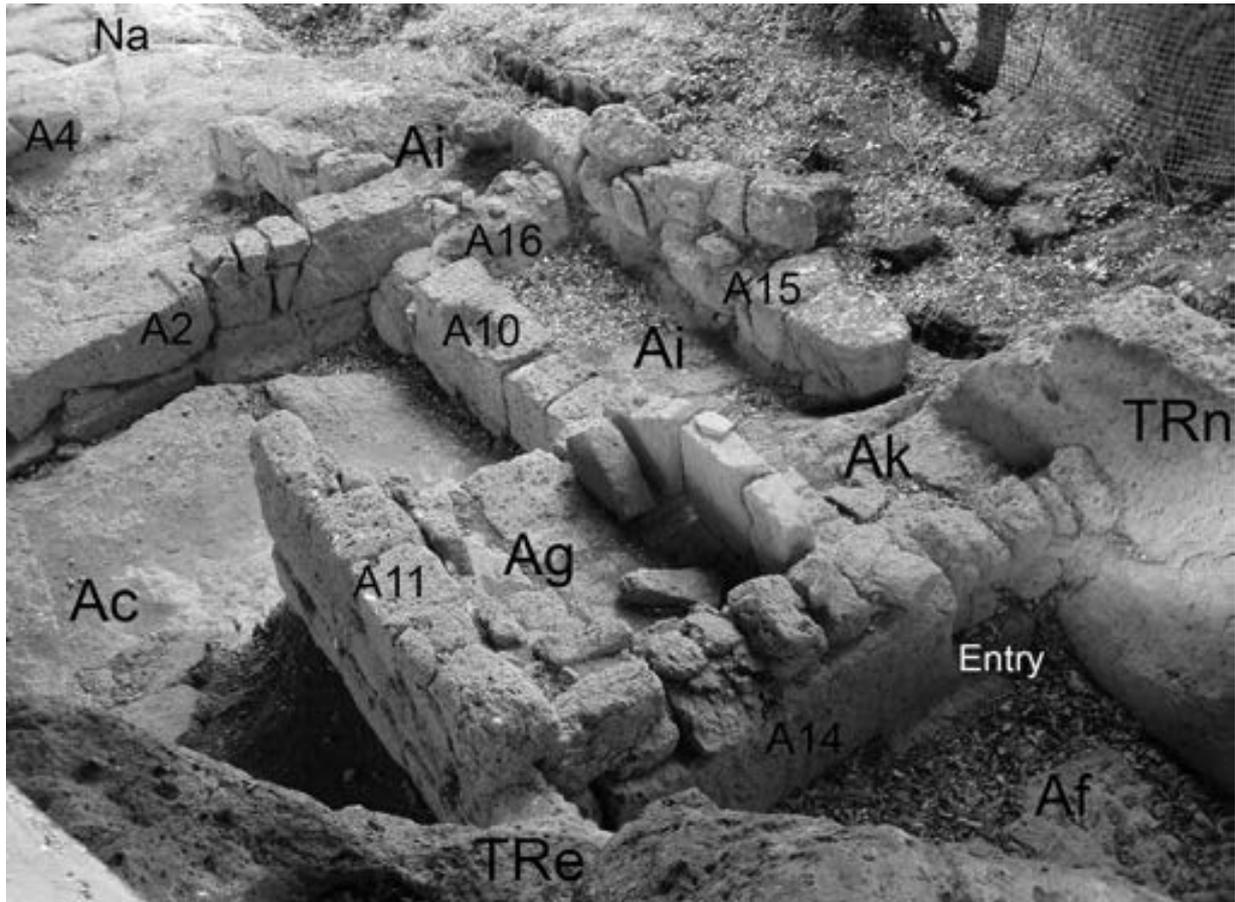
Fig. 131. Work area Ac and niches Ag-Af-Ak from the south-east.
