Opuscula

14
2021

The cisterns of the Bisti promontory at Hermione

With a preliminary description of the Roman aqueduct

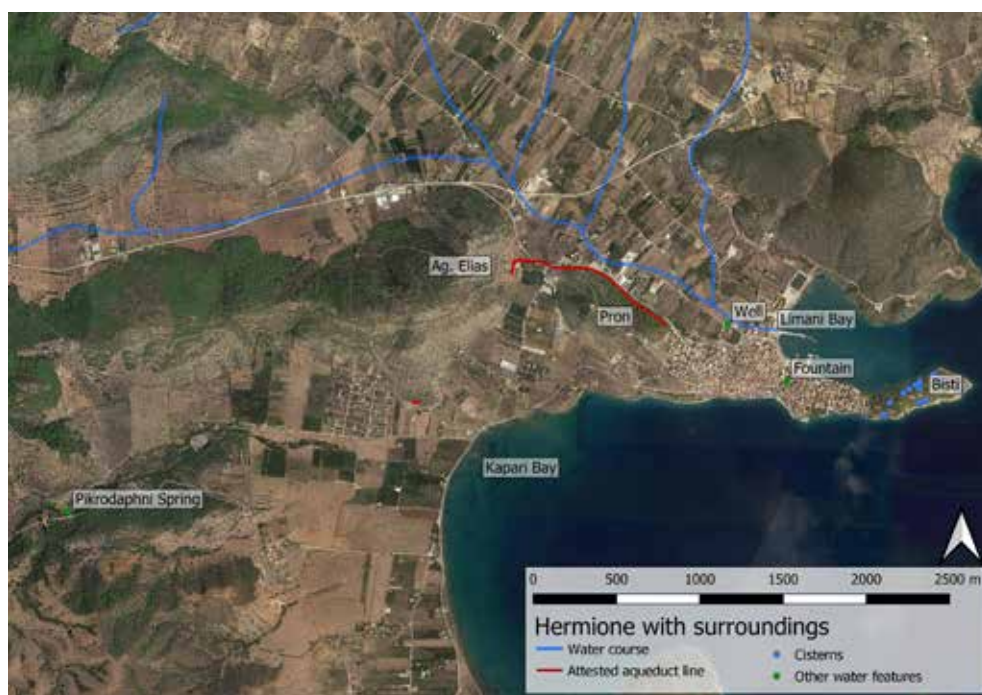
Fig. 1. Map over the area of Hermione with attested sections of the aqueduct (red), the local watercourse (blue), cisterns (blue circles), and other selected water installations (green circles). Illustration by Patrik Klingborg, basemap by Google, ©CNES/Airbus, European Space Imaging, Landsat/Copernicus, Maxar Technologies, Map data 2021.

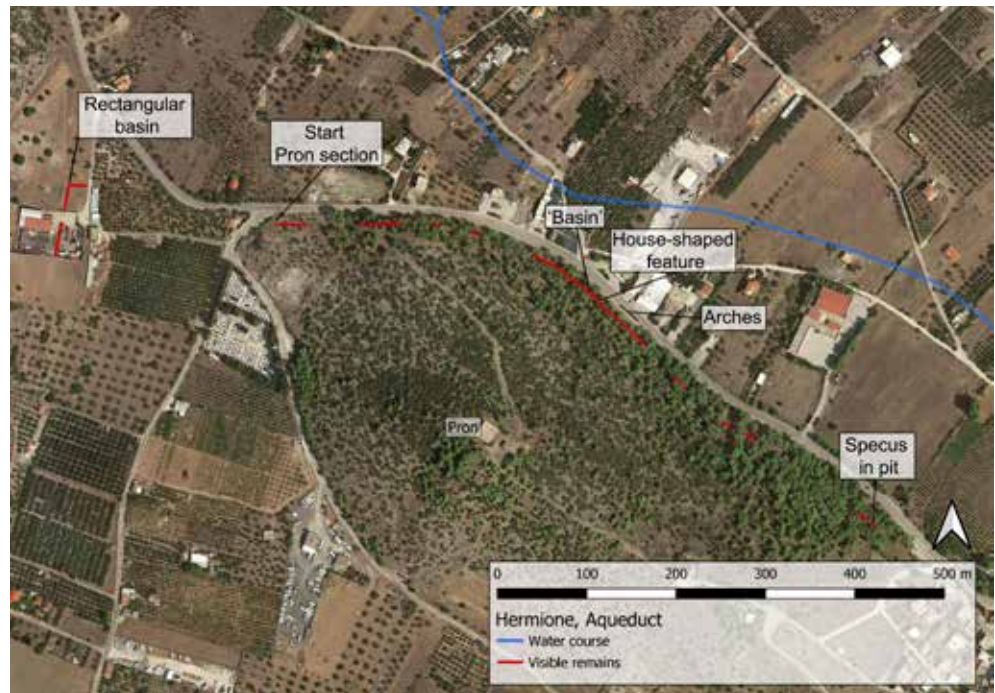
Fig. 2a. Detail of the aqueduct along Pron Hill. Illustration by Patrik Klingborg, basemap by Google, ©CNES/Airbus, European Space Imaging, Maxar Technologies, Map data 2021.

Another 15 m east from this feature the solid wall of the aqueduct is pierced by five low arches (Figs. 2a, c). These have been noted by several previous scholars.³⁰ The arches all seem to have rested on a solid continuous wall. The first arch from the west is the best preserved. It measures 1.50 m across at the base with an estimated height of 0.75 m. Practically all of the voussoir stones are preserved. On the inside of the arch the imprints in the mortar of at least four wooden planks forming the formwork used to create the arch are visible (Fig. 2d).³¹ At the east base of the arch there is a wall abutting the foundation on the downhill side. The second arch is in a comparably poor state with most of the voussoir stones gone. The original diameter can be estimated to have been about 1.50 m, the height 1.00 m. The third, middle, arch has collapsed completely, leaving a gap in the aqueduct. The fourth arch still remains with a width of 1.70 m and height of 0.90 m. Notably, the outer layer of stones for the arch has been removed, leaving only an imprint. Between the fourth and fifth arch the imprint in the lining of a 0.15 m wide supporting wall can be seen. The dimensions of the fifth arch are similar to those of the fourth, and again the stones of the arch have been removed. A wider support wall, 0.55 m high and 0.55 m wide, abutted the aqueduct just to the east of the fifth arch.

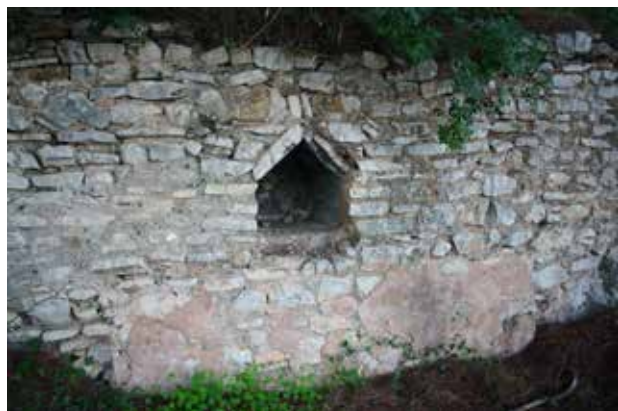
Fig. 2b. House-shaped feature in the aqueduct. Note the pink plaster covering the aqueduct. Photograph by Patrik Klingborg.

the lower area between the Aghios Elias and Pron Hill where the watercourse once flowed, presumably using arcades, none of which are preserved today. According to Gkatsos they could be observed to a height of four metres in 1980.²⁴ They are also visible in a photograph in a book about local herbs published in 1988.²⁵ From the west foot of the Pron the aqueduct clings to the north slope just above the modern road. The first preserved part at the west end of the Pron, located 235 m from the rectangular basin, is formed by a solid wall 2.25 m high and 0.95 m wide (Fig. 2a). As with the rest of the aqueduct, this section is constructed in a rubble stone masonry formed by small roughly rectangular stones bound together with a generous amount of mortar in between, often more than 0.03 m, sometimes up to 0.10 m. Almost no materials of terracotta were observed in any of the preserved sections, indicating that this was used only sparingly (Figs. 2b–c).

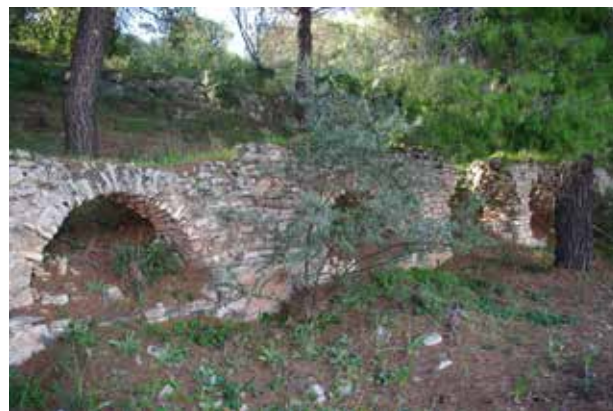
Fig. 2c. The section with the arches. Photograph by Patrik Klingborg.

While these arches would allow humans and animals to pass through, albeit not very comfortably, this was probably not their primary function. Similarly, the reduction in material used was rather minimal. Instead it seems likely that the arches were intended to allow rain water, perhaps even winter torrents (known as *χαράδραι*), to pass through. This interpretation is corroborated by the three walls abutting the aqueduct on the downhill side in this area, indicating that the structure was under considerable stress.

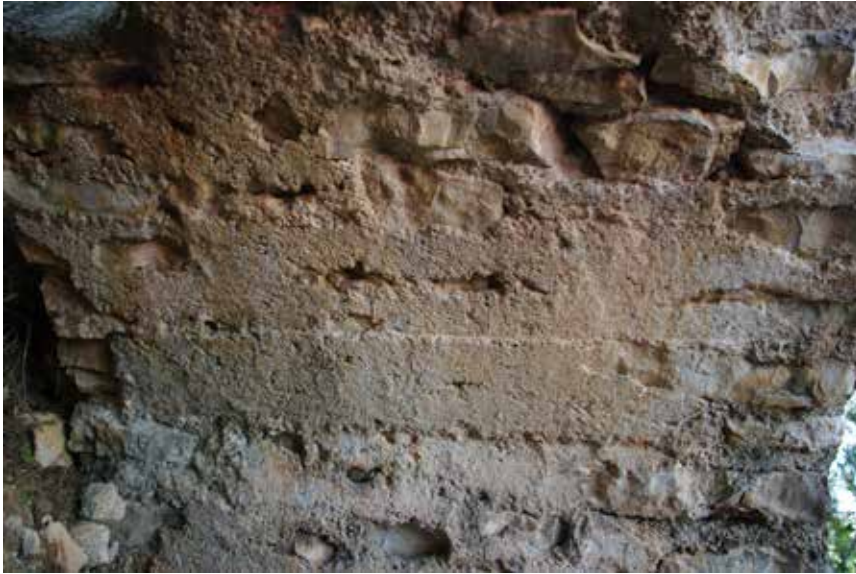
Fig. 2d. Imprints in the mortar of wooden moulds from the construction of the first arch from the west. Photograph by Patrik Klingborg.

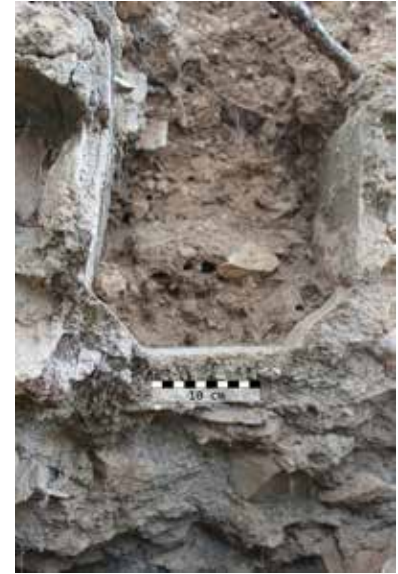
Fig. 2e. Specus of the aqueduct. Photograph by Patrik Klingborg.

After the arches the aqueduct continues until, at 660 m from the rectangular basin, another wall abuts the aqueduct on the downhill side. This wall is 1.20 m long and 0.40 m high. At about 2.30 m to the east from this supporting wall a weeping hole measuring 0.20 × 0.30 m is found at the top of the aqueduct. After this point the aqueduct is often completely hidden underground and visible only intermittently further to the east. The last location where the aqueduct can be securely identified is located just over 1 km east (following the course of the structure) from the rectangular basin. Here a pit exposes the best-preserved section of the *specus* visible today (Fig. 2e).

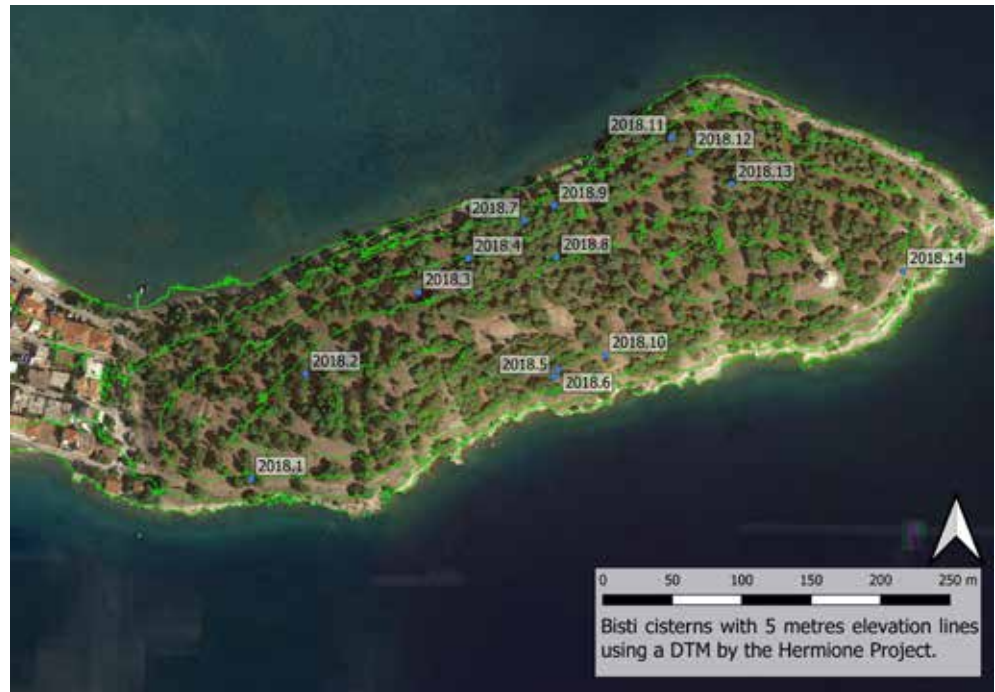
Fig. 3. The Bisti promontory with cisterns indicated. Illustration by Patrik Klingborg, basemap by Google, ©CNES/Airbus, European Space Imaging, Maxar Technologies, Map data 2021.

The fieldwork within the framework of the Hermione project recorded 14 potential cisterns during the 2018 season (Fig. 3). Of these, the nature of two (2018.6 and 2018.14) must be considered uncertain. One cistern (2018.12) appears to have been left unfinished in antiquity based on the lack of a lining. It is likely that a considerable number of cisterns are completely filled in and not visible today. This assumption is corroborated by the unknown cistern marked on the map by Frickenhaus and Müller (Gerding 2021, fig. 2) as well as a preliminary analysis of the results from Derek Pitman’s magnetometry survey in 2018.⁴⁴ Scholars have also noted further ancient cisterns in the modern city of Hermione, but without providing specific information.⁴⁵ However, at least two cisterns of unknown date can be seen in the city today. One is located in an abandoned plot *c.* 85 m east of the Taxiarches Church. This cistern is completely subterranean and the visible section pithos-shaped, possibly indicating a Roman or even considerably later date. Another cistern is located *c.* 55 m north-west of the same church. This cistern probably post-dates antiquity by a considerable margin considering its shallow depth (probably no more than 2.50 m) and because the mouth is situated 0.50 m above the modern street level.

Notably, the cisterns are unevenly located on the Bisti (*Fig. 3*). Eight (**2018.3**, **2018.4**, **2018.7**, **2018.8**, **2018.9**, **2018.11**, **2018.12** and **2018.13**) are found on the north side, only one (**2018.2**) on the ridge, and five on the south side (**2018.1**, **2018.5**, **2018.6**, **2018.10**, and **2018.14**). Eight of the cisterns (**2018.3**, **2018.4**, **2018.5**, **2018.6**, **2018.7**, **2018.8**, **2018.9**, and **2018.10**) are located in the central area. Only two (**2018.1** and **2018.2**) are located in the western third of the promontory and four (**2018.11**, **2018.12**, **2018.13**, and **2018.14**) on the eastern third. Of the cisterns almost half (6 out of 14) are located between 20 and 25 m from the water-line (**2018.7**, **2018.9**, and **2018.11** on the north side, **2018.1**, **2018.5**, and **2018.10** on the south side).

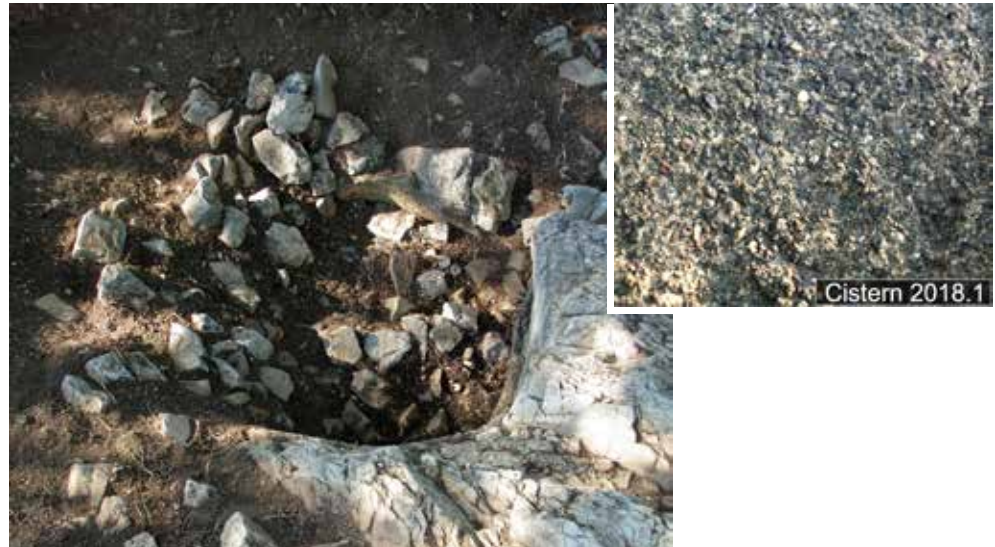
Fig. 5. Cistern 2018.1, mouth, with a diameter of 90 cm. With detail of lining. Photographs by Patrik Klingborg.

The westernmost cistern is found 18 m north of the south coast and 95 m from the modern south entrance to the Bisti (Fig. 5).

The cistern is filled almost to the top with modern refuse, stones, and organic material. Consequently, no more than 35 cm of the neck is visible. The mouth is formed by an irregular circle, 90 cm in diameter east–west where the full circumference can be seen. The irregularity of the mouth suggests that its ancient counterpart was higher up. The loss of the original neck and mouth is also supported by the observation that the neck seems to expand into the body just under the modern rubble. The lining in the cistern is a pale yellow, tending towards white where recently fractured. Small pebbles 0.1–0.2 cm in diameter are common in the lining. The thickness of the lining is 2–3 cm in most areas, but some sections are as thin as 1.5 cm. In a sharp bend the lining is up to 5.5 cm thick.

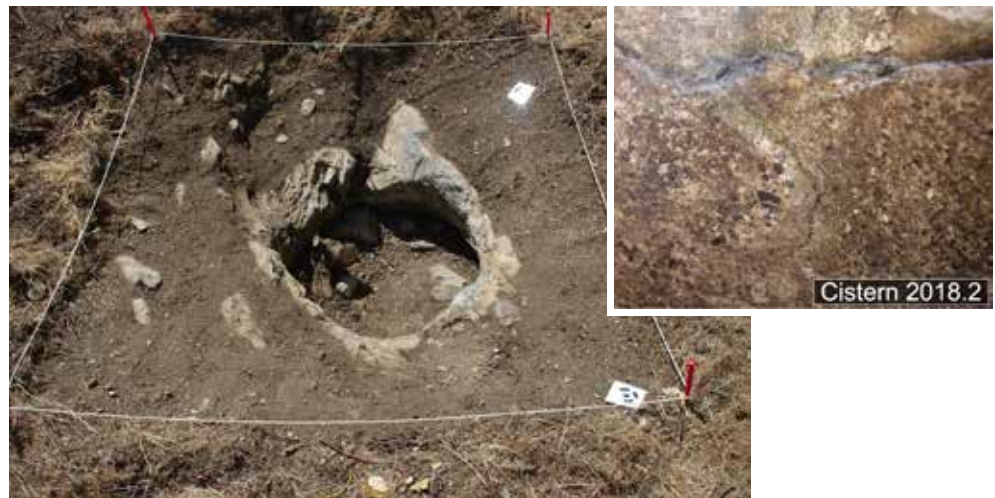
Fig. 6. Cistern 2018.2, mouth, with a diameter of 90 cm. With detail of lining. Photographs by Patrik Klingborg.

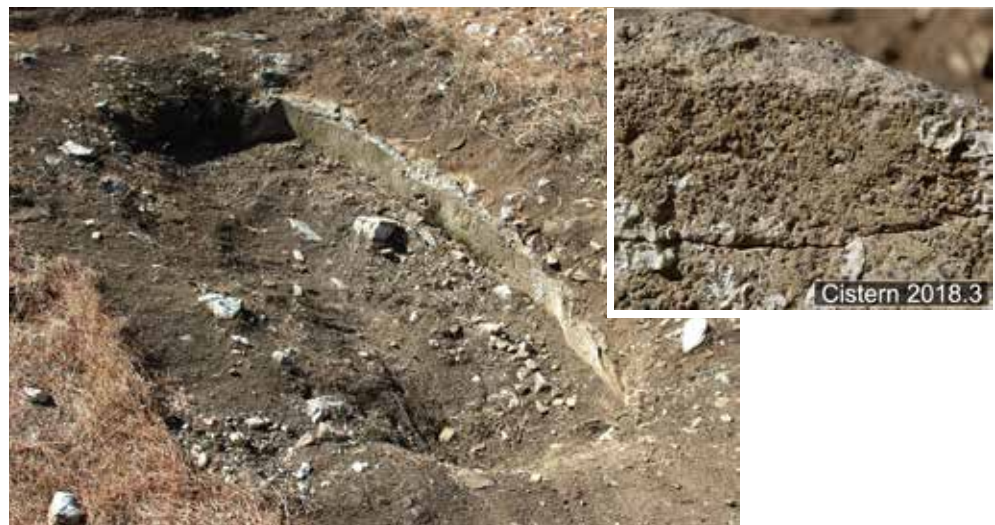
Fig. 7. Cistern 2018.3, general view. With detail of lining. Photographs by Patrik Klingborg.

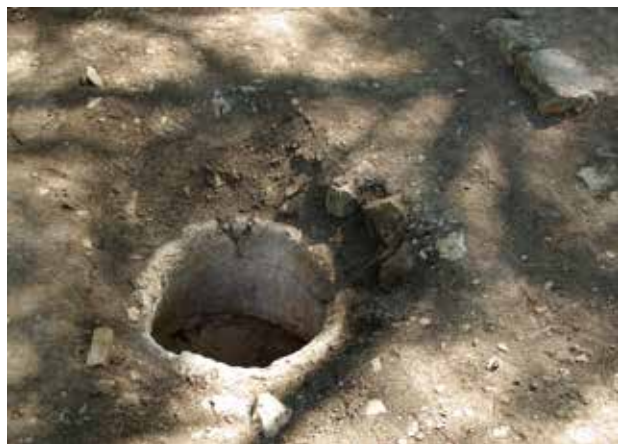
Fig. 8. Cistern 2018.4, surface view showing the 53 cm wide opening and the repaired section. Photograph by Patrik Klingborg.

Another cistern is located 45 m south of the northern shore of the Bisti and 50 m north-west of the temple foundations (Fig. 8). Unlike the previous cisterns this one remained unfilled to a level of 150 cm below the surface, ensuring that the capstone, neck, and upper body were visible. About 90 cm to the south of the cistern at least two stones seemed to form a wall running east–west with two further stones possibly belonging to the same stretch.

The opening of the cistern is formed by a capstone cut from one single block. While the outer dimensions of this block are unknown, the opening is circular, 50 cm deep, and slightly funnel shaped with an upper diameter of 53 cm and lower diameter of 65 cm. On the inside a thin layer may be the remains of lining or incrustations. At the south-east side

a rectangular and slightly concave block, 40 cm long and 12 cm high, is carefully inset in the capstone, indicating that this had been damaged and repaired at some point (Fig. 8, top right of the cistern opening). Across from the repaired section, in the north-west side of the capstone, a depression may indicate the location of the inflow channel. A possible cutting for a lead clamp can be seen on the west surface of the capstone. Moreover, on the south side of the capstone three stones suggest that the mouth was raised during the cistern's period of use as a water source (Fig. 8).

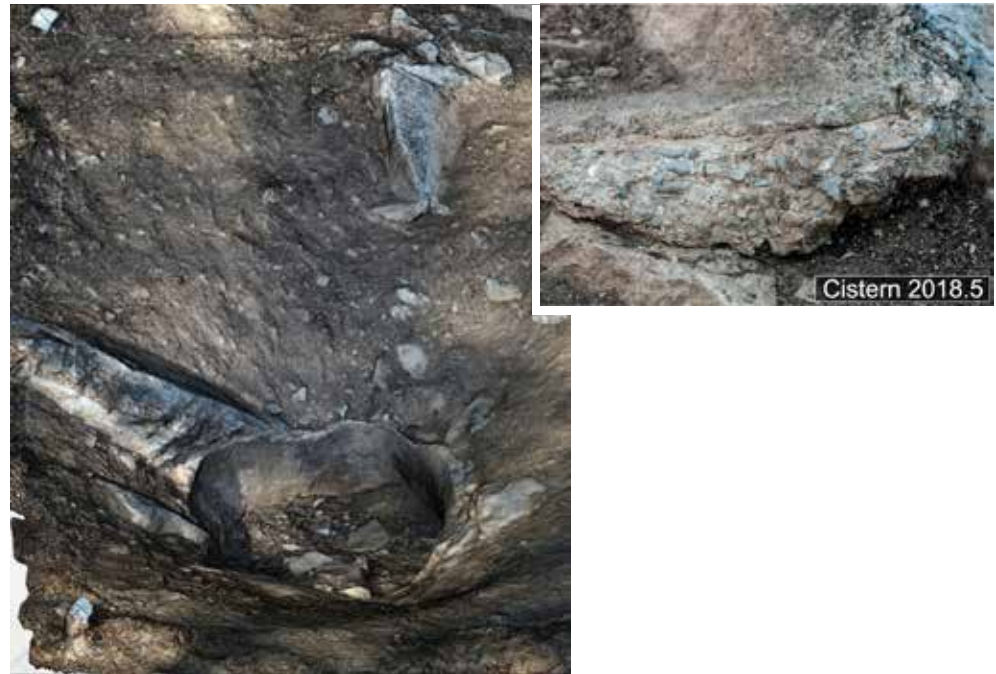
Fig. 9. Photogrammetry model of cistern **2018.5**, mouth, with a diameter of 90 cm and the lined section in the top right corner. Illustration by Hanna Håkansson. With section of the lined feature. Photograph by Patrik Klingborg.

On the other side of the Bisti a cistern is situated 35 m south of the central part of the edge of the temple foundations, and 25 m north of the south coast (Fig. 9). It was filled almost to the top with modern refuse and pine needles.

The preserved mouth of the cistern is round with a diameter of 90 cm. Below the top of the mouth the neck is clear of refuse for 35 cm. Another 10 cm of depth is visible under the rubble fill. Possibly the cistern begins to expand into the body at this point. On the north side of the mouth and neck a small outwards bulge is found, continuing from the preserved top to the visible bottom. This may indicate where the inflow was originally located. The lining is a pale yellow in colour and composed of a cruder inner and finer outer layer. Together they form a 1–9 cm thick surface, with the thickest areas being found in a “corner”. The inclusions in the cruder inner layer are up to 1 cm in diameter.

About 1 m above the cistern a single lined stone block was found (Fig. 9, top right). It was unclear whether the block was loose or part of the bedrock. As in the cistern below, the lining on the block was executed in two layers. The inner was cruder and up to 5.5 cm thick, the outer considerably finer and only 0.7–1 cm thick. The outer layer was, however, not as smooth as that in many of the other cisterns. Near the bottom the lining makes a sharp turn from a sloping direction into a horizontal surface. It is unclear what this feature was. It may be part of the original neck of the cistern, in which case the horizontal surface probably formed a climbing hole. Such a loose climbing hole is known from a collapsed cistern at Agrioleza in Attica.⁵¹ Another possibility is that it was part of a water channel leading to cistern 2018.5 from above, possibly cistern 2018.6. Finally, it could be part of a *prolakkion*, i.e. a water basin located before the cistern and used to remove silt and other impurities (Fig. 4).⁵²

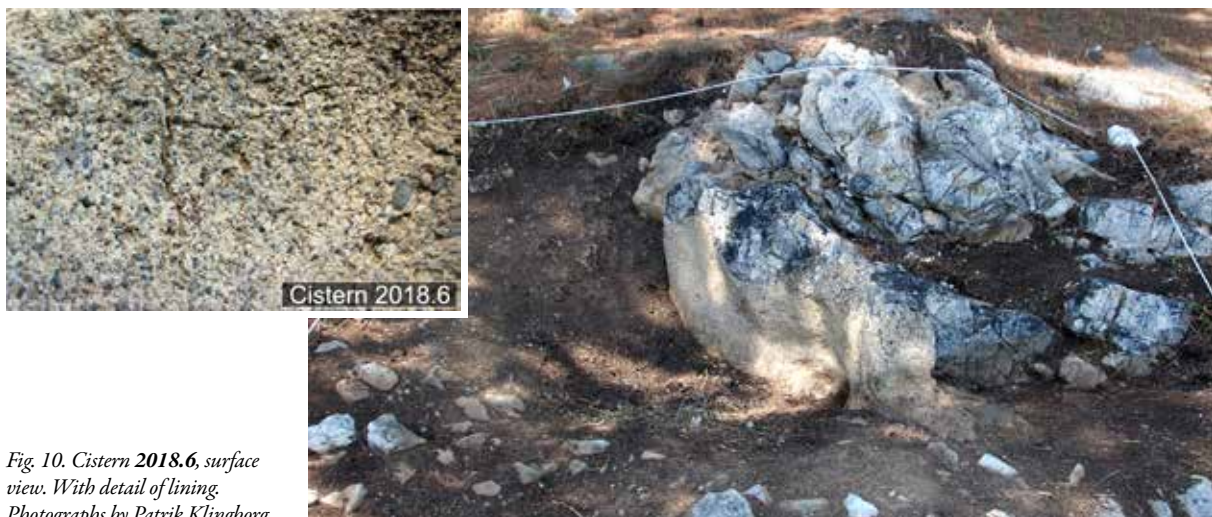
Fig. 10. Cistern **2018.6**, surface view. With detail of lining. Photographs by Patrik Klingborg.

At present there is not enough evidence to identify this installation as a cistern with reasonable certainty. It is equally possible that it was a *prolakkion* for cistern **2018.5**. The connection between cistern **2018.5** and **2018.6** is strengthened by similarity in lining and the presence of the lined feature situated between them.

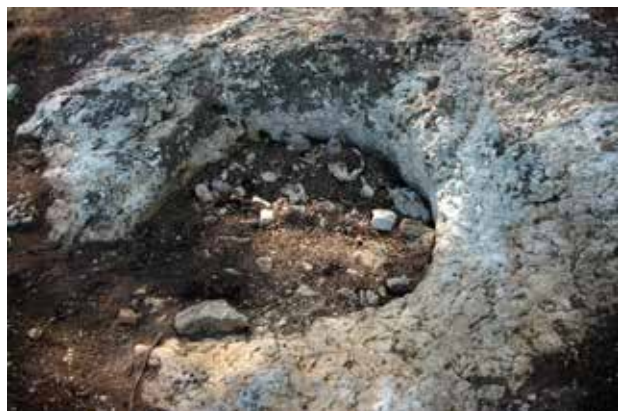
Fig. 11. Cistern 2018.7, mouth, with a diameter of 110–115 cm. Photograph by Patrik Klingborg.

On the north side of the Bisti, 23 m from the northern shore and 65 m north of the temple the round mouth of a cistern is found (Fig. 11). Almost the whole circumference is preserved, measuring 110 cm east–west and 115 cm north–south. There

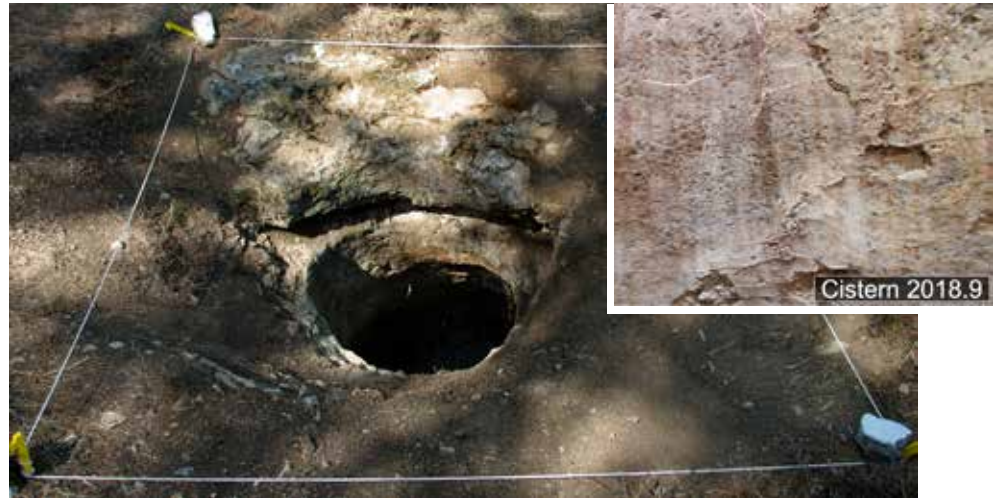
Fig. 12. Cistern 2018.9, mouth, with a diameter of 76–79 cm. With detail of lining. Photographs by Patrik Klingborg.

The next cistern is found about 15 m north-east from cistern **2018.7** and 27 m to the south of the north coast. Today the mouth, neck, and upper part of the body are clearly visible to a depth of 190 cm and in a good state of preservation

(Fig. 12). The fill is a mix of rocks, organic material, and modern refuse.

The preserved mouth of the cistern is almost circular, measuring 76 cm east–west and 79 cm north–south. The maximum depth of the neck is 70 cm, but the upper 30 cm is only preserved on the west side. Below this there is a 20 cm long crack under which the full circumference of the neck is preserved, although less well on the south side, before expanding into the body. Presumably a natural crack ran through the bedrock forcing the neck to be constructed rather than cut on the south, east, and north side. Notably a large fragment of a ceramic vessel, possibly a body sherd from an amphora, was visible in the soil and stone wall above the preserved neck on the south side. It is possible that this belongs to the material used when building the upper section of the neck.

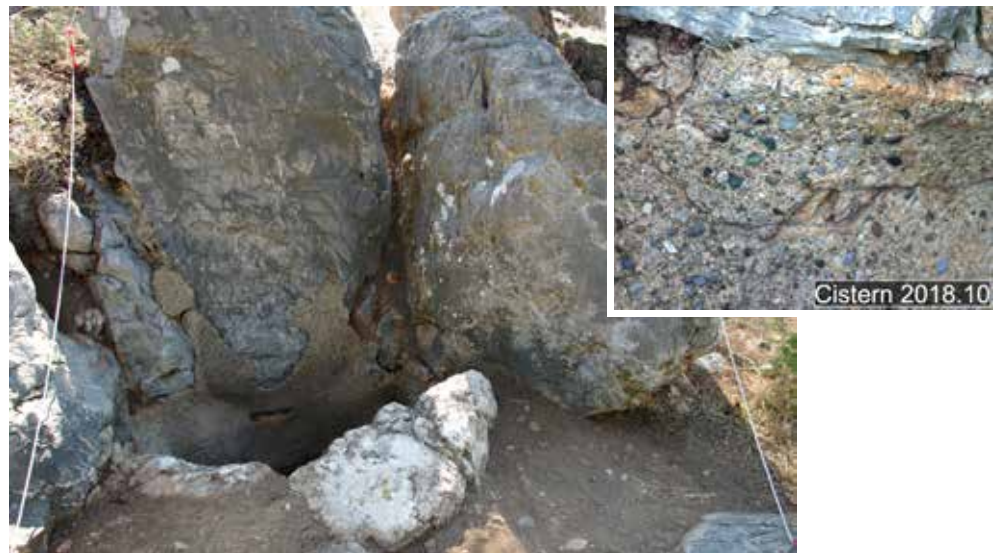
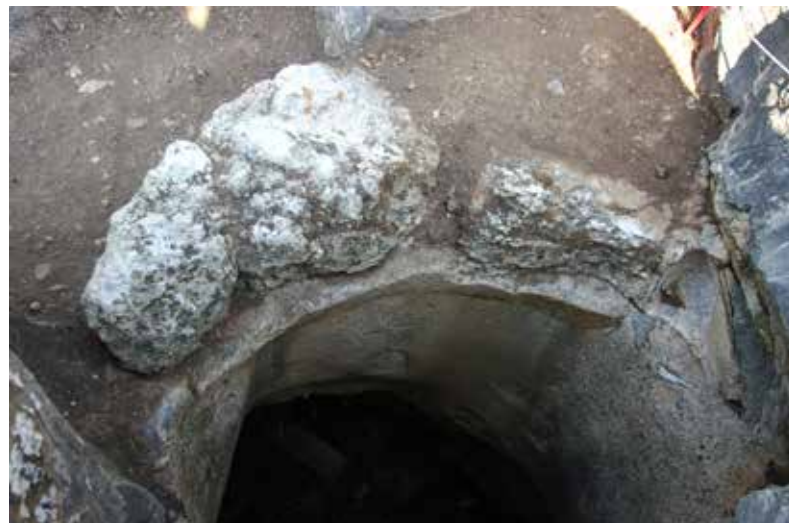
Figs. 13a–b. Cistern 2018.10, a) upper section and opening, with the mouth measuring 75 × 120 cm, b) neck masonry. With detail of lining. Photographs by Patrik Klingborg.

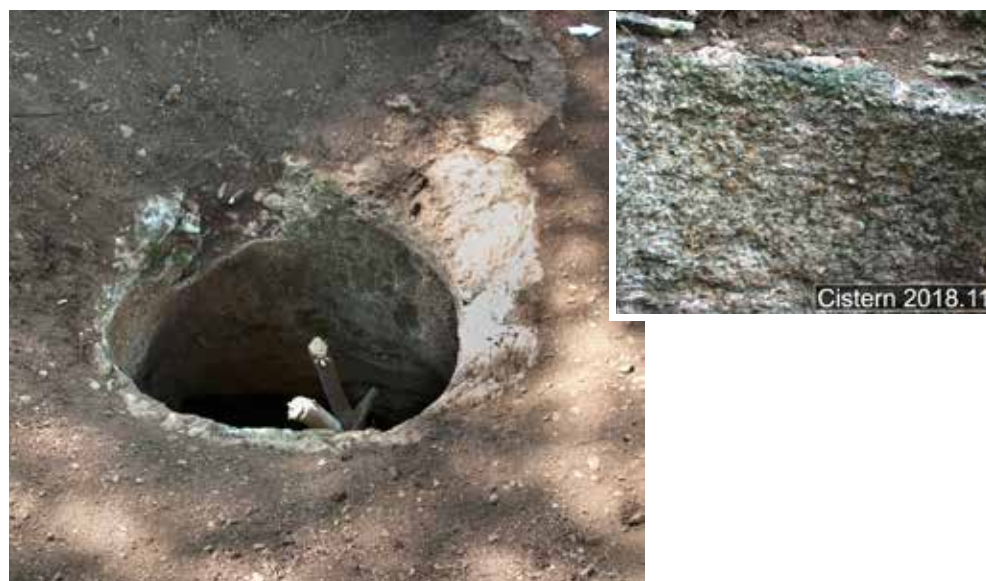
Fig. 14. Cistern **2018.11**, mouth, with a diameter of 85–90 cm. With detail of lining. Photographs by Patrik Klingborg.

The next cistern is found on the north side of the Bisti, about 25 m from the coast and approximately 45 m from the point where the coast of the promontory turns south. The opening and a large section of the body can be seen (Figs. 14). Inside the cistern modern refuse competed for space with a young fig tree.

With the exception of a small section in the south-west the whole circumference of the mouth, measuring 90 cm east–west and 85 cm north–south, is preserved at the modern surface level. The neck reaches a maximum depth of 40 cm. Below this the body of the cistern expands into an irregular flask

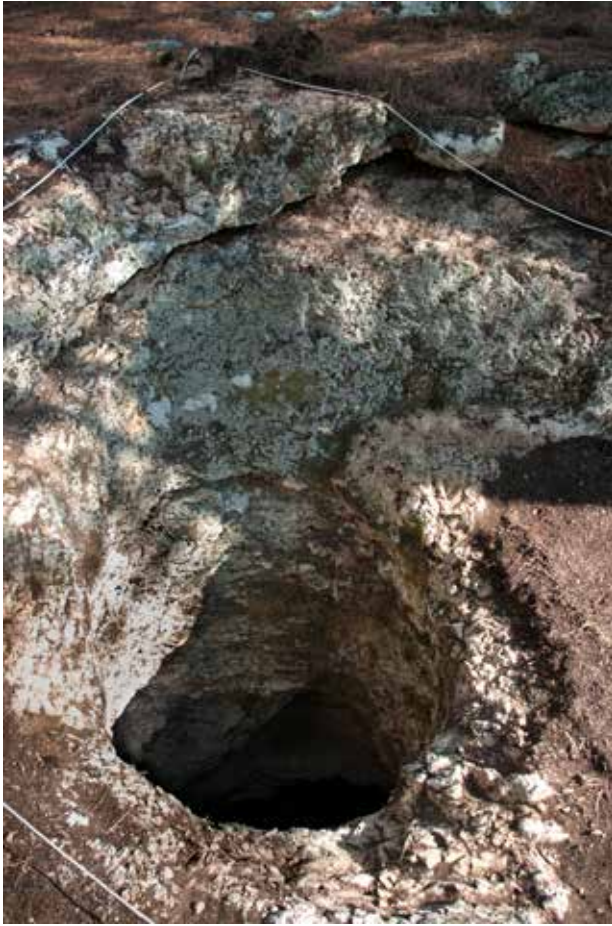
Fig. 15. Cistern 2018.12, upper section and opening. Photograph by Patrik Klingborg.

About 20 m directly south-east of cistern **2018.11** and 45 m south of the north coast a further cistern is found (Fig. 15). It is superficially similar to cistern **2018.10** with an upper section cut in a rock outcrop face and a neck continuing down below the modern surface until it expands into the body. As with the other cisterns a deposit of rocks, organic material, pine needles, and soils is visible at the bottom. Overall, this cistern is in a poor state of preservation.

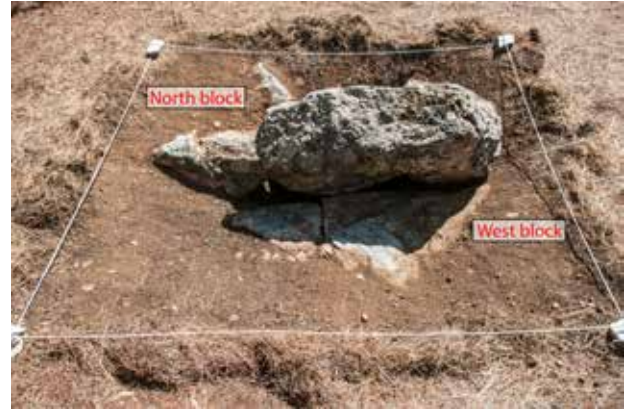
Fig. 16. Cistern 2018.13, surface view. Photograph by Patrik Klingborg.

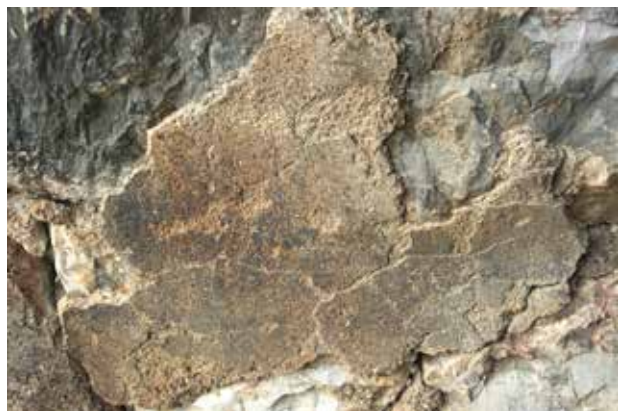
Fig. 17. Lining of cistern 2018.14 with miscolouration. Photograph by Patrik Klingborg.
