Plate 1. Archaeological masonry plan of the area without letters.

Plate 2. Photographic montage of Borgos NW of images from the photographic tower, *la giraffa*, by B. Blomé (1961–1963).

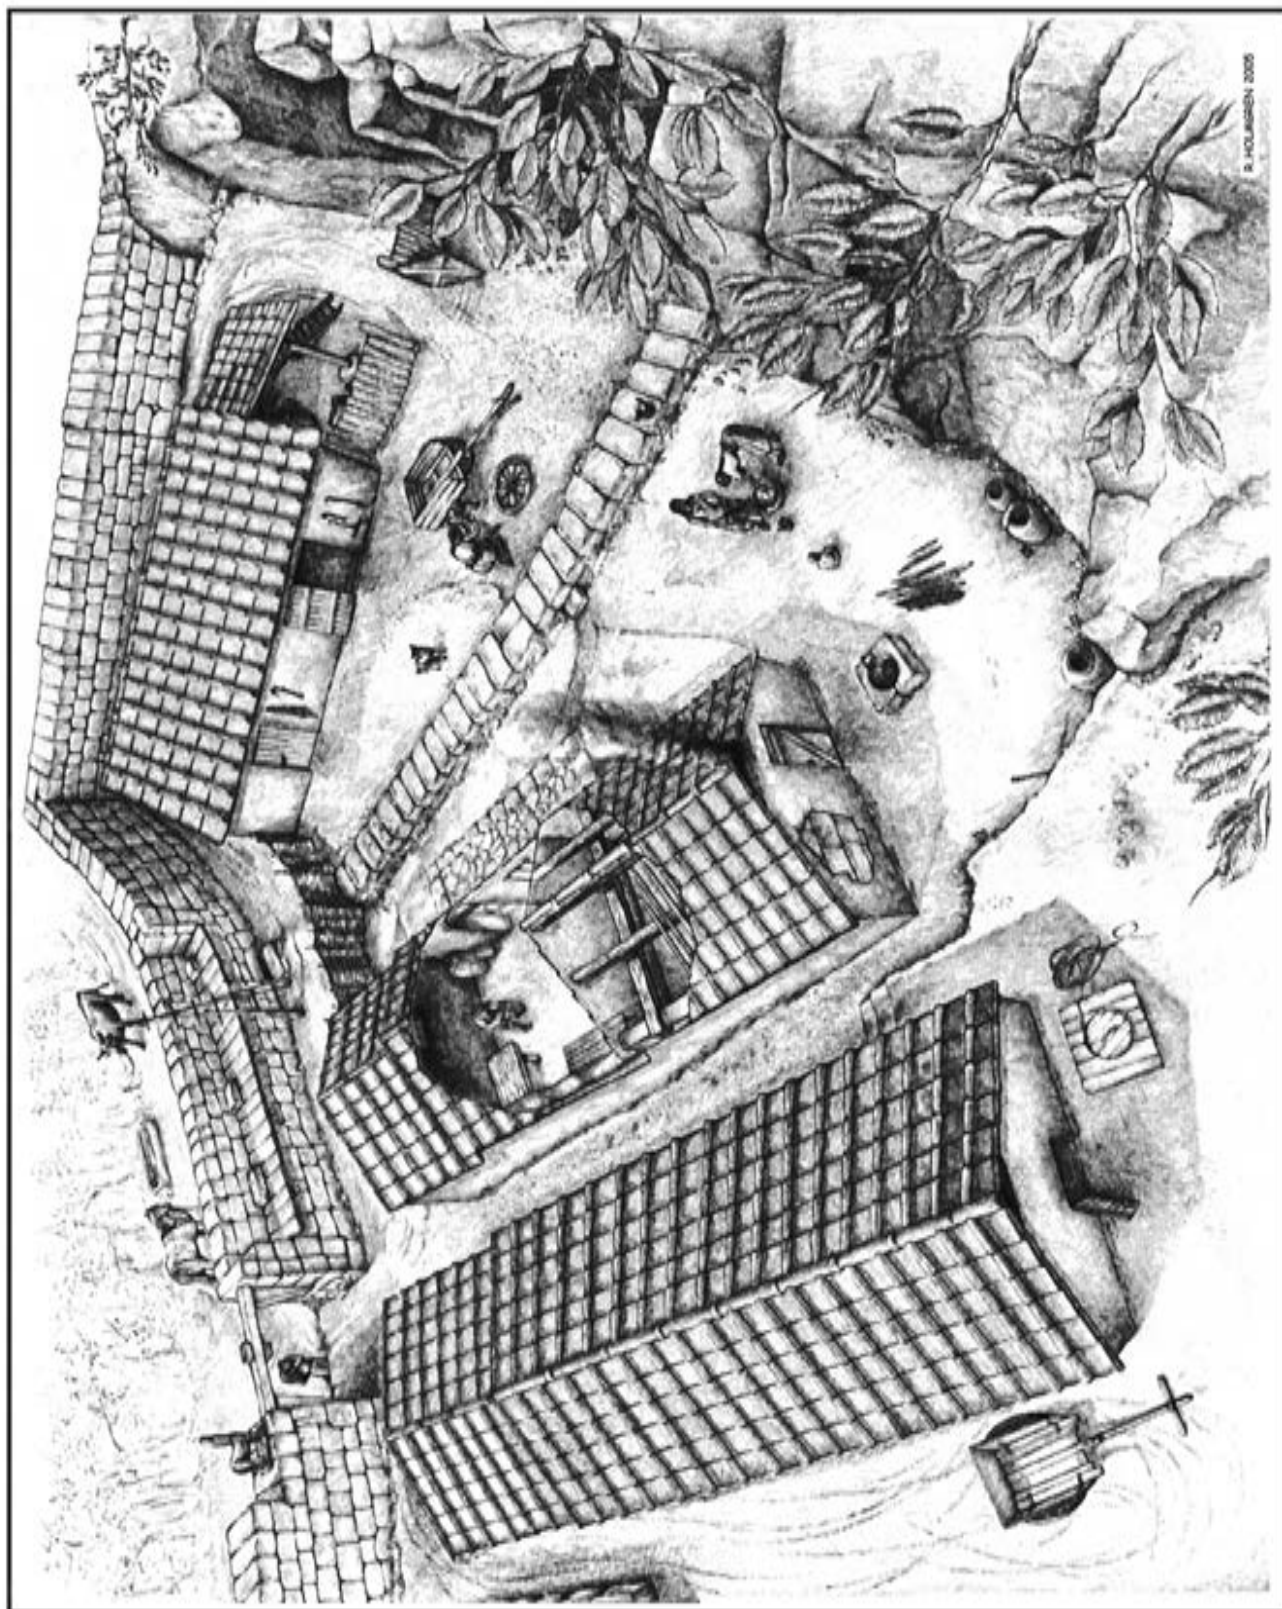
Plate 3. Reconstruction of Borgos NW at Periods 1 and 2. The area is seen from the Borgo Spina rock in the south-east. Illustration: ARCDoc, by R. Holmgren.

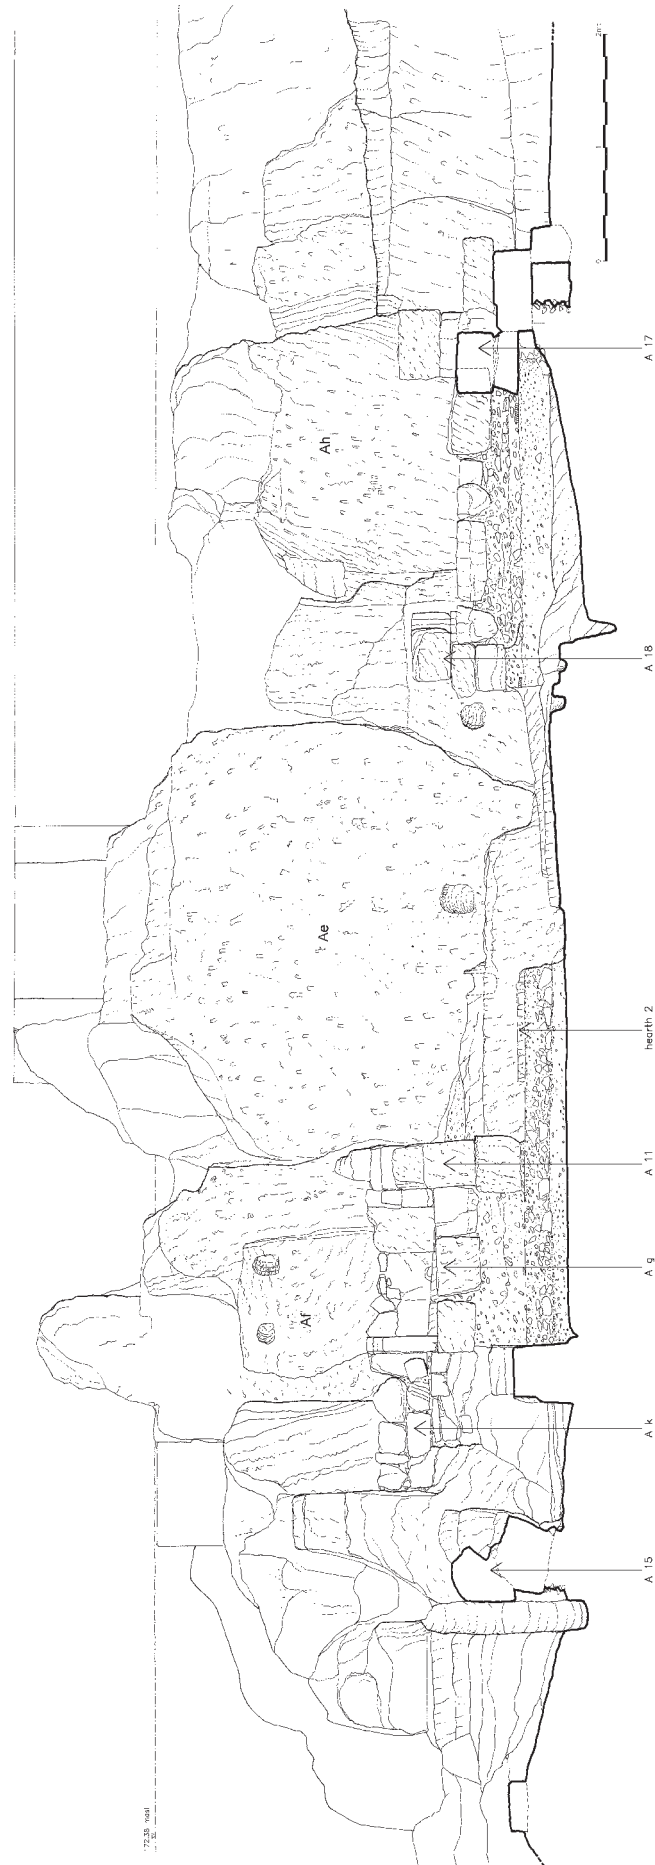
Plate 4. Section G1. View towards the rock outcropping from the west.

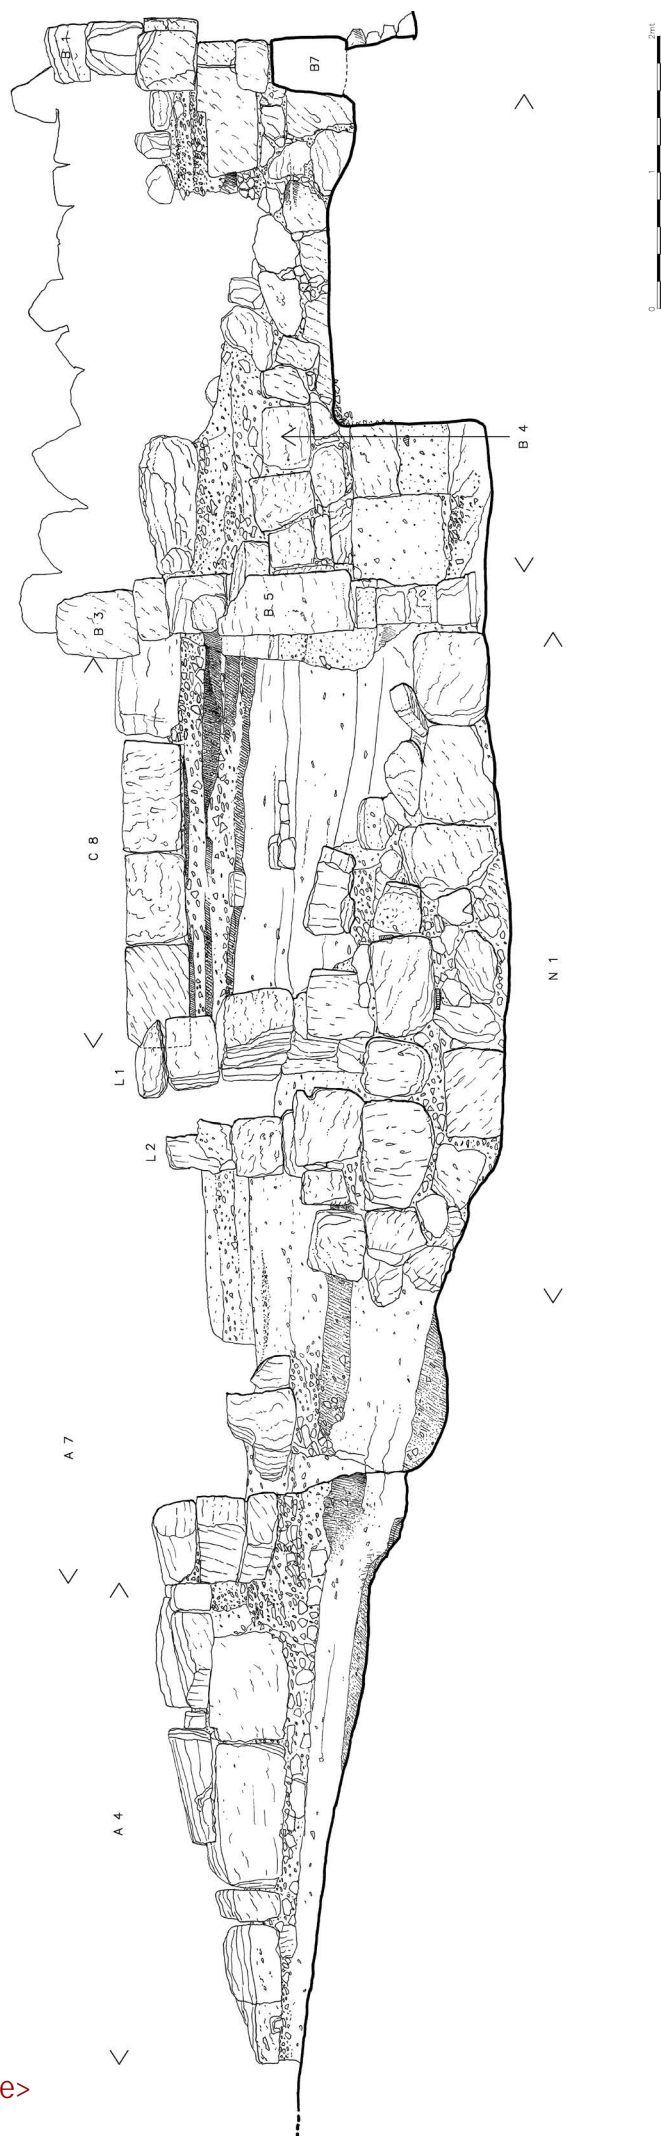
Plate 5. Section G2. View from the north-west of walls A4-A7-L2-L1-C8-B3-B5-B4-B1-B7.

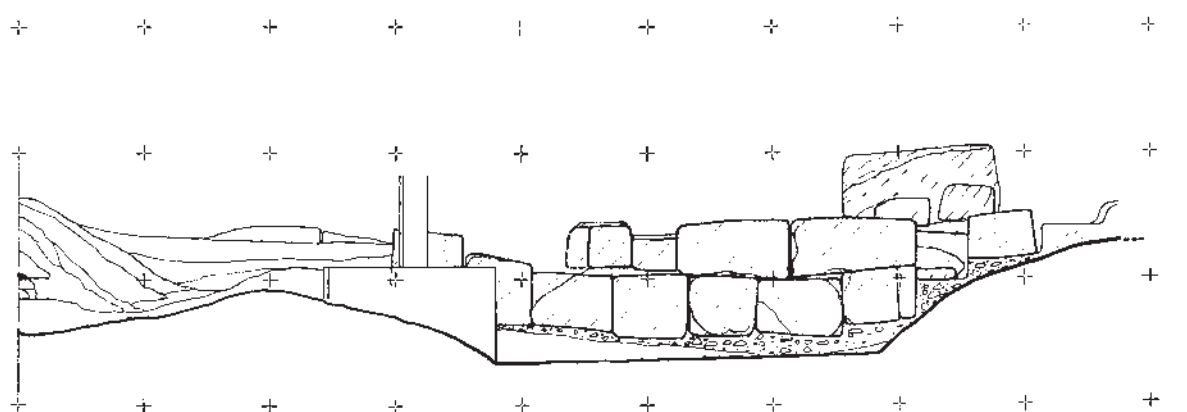
Plate 6. Section L1. View from the west of rock Na, wall Mc.

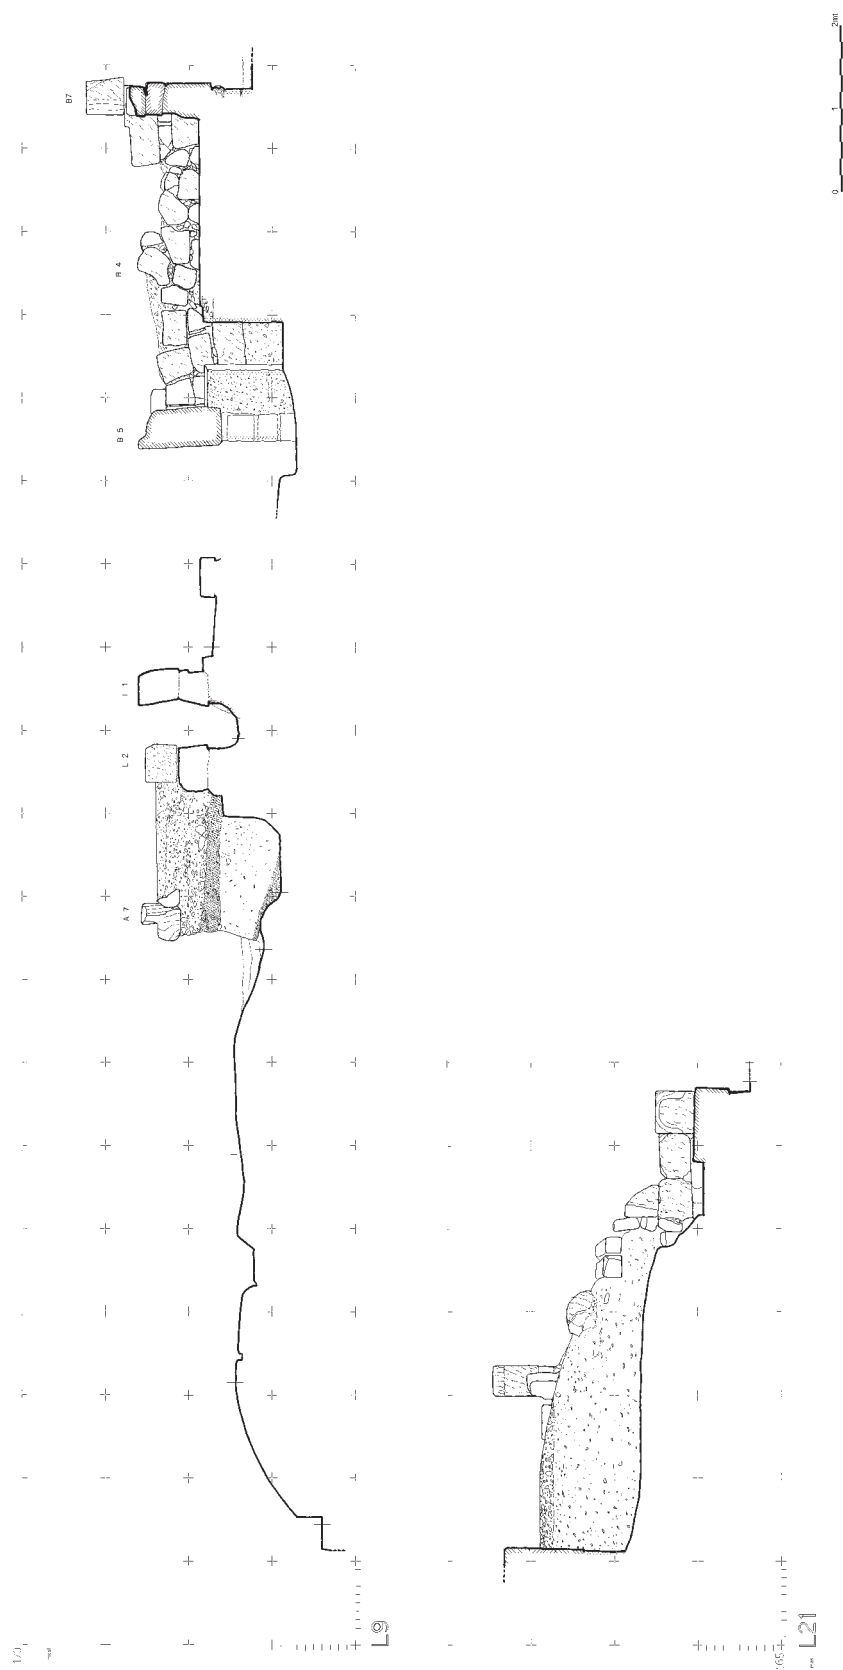
Plate 7. Section L9. View from the west of rock Na, room Ab, through walls A7-L2-L1-B5, elevation of wall B4, through wall B7 + Section L21. View from the west through walls A3-A1 and room Aa (in one drawing).

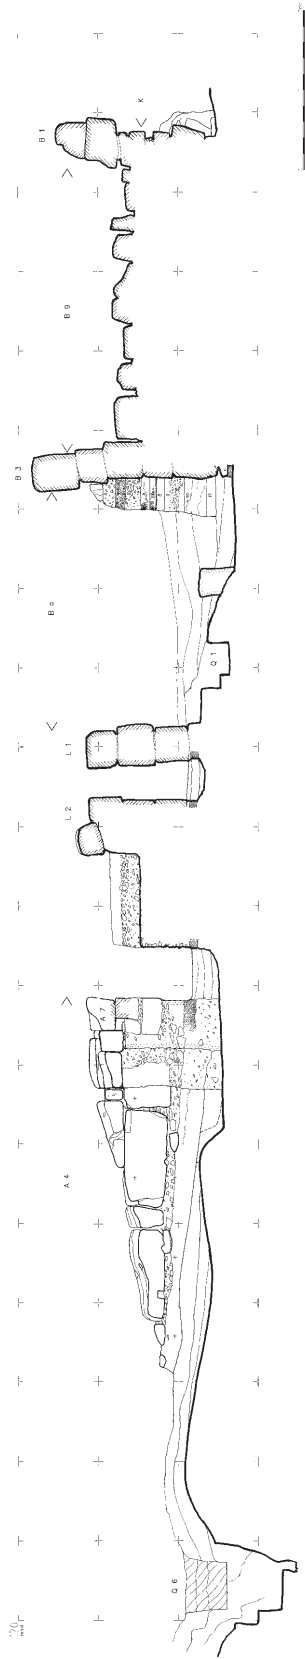
Plate 8. Section L11. View from the west through canal Q6, room Ab, elevation of wall A4, through wall A7, yard Ad, through walls L2-L1, canal Q1, walls B3-B9-B1.

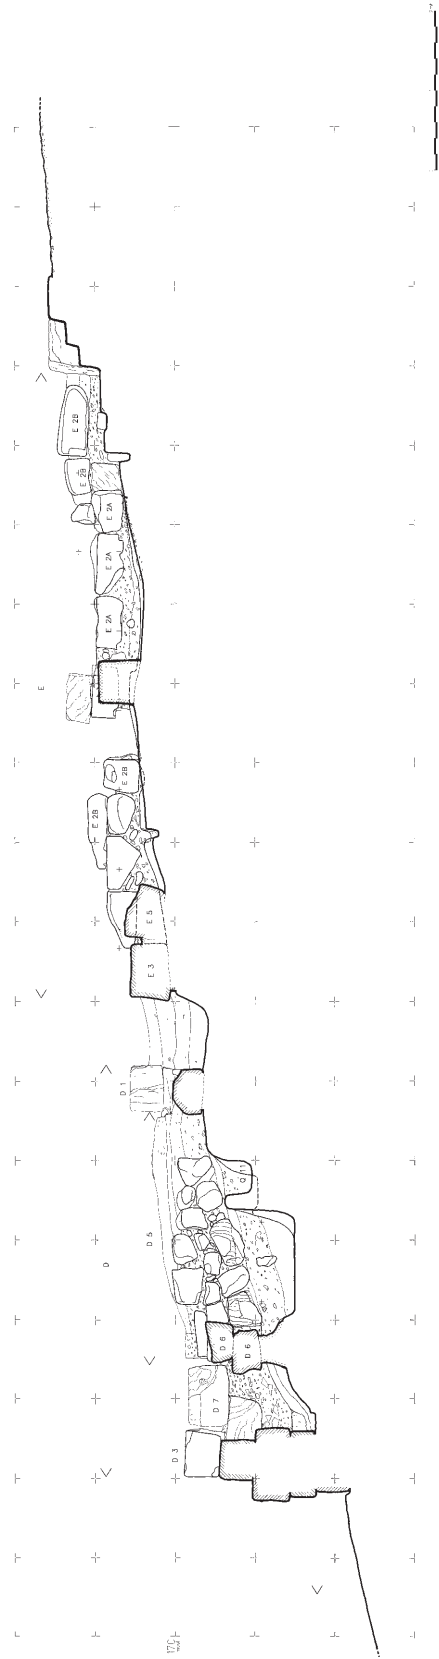
Plate 9. Section L12. View from the west through wall D3, elevation of wall D6, through wall D5, through walls D1-E3-E5, elevations of walls E2a and E2b.

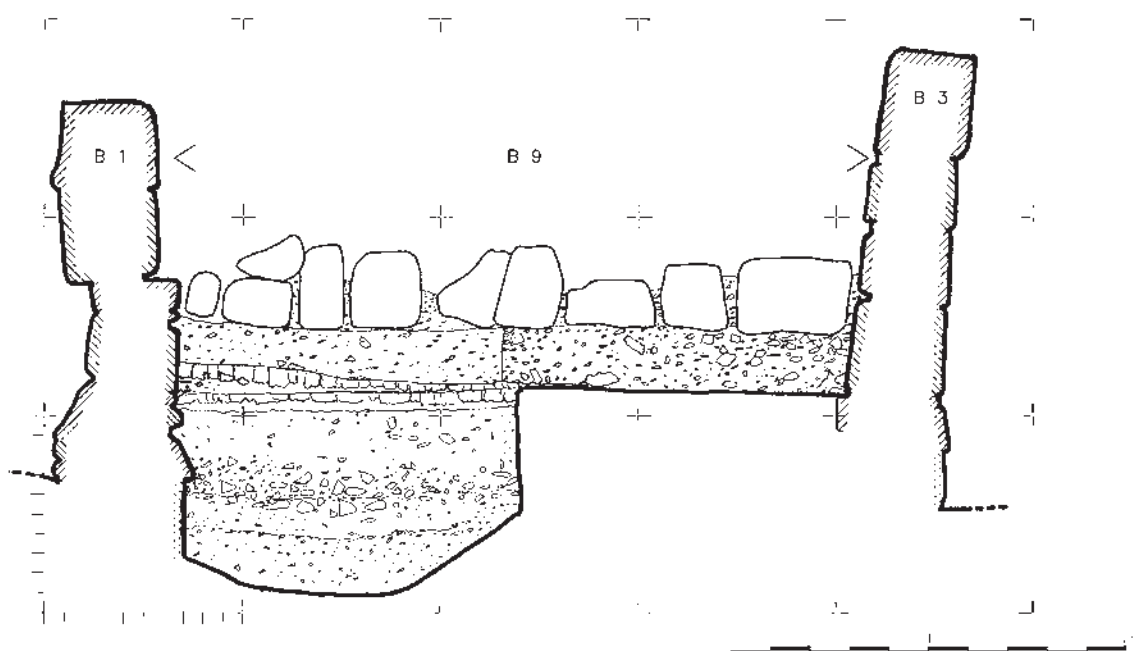
Plate 10. Section L13. View from the east through wall B1, room Ba, elevation of wall B9, through wall B3.

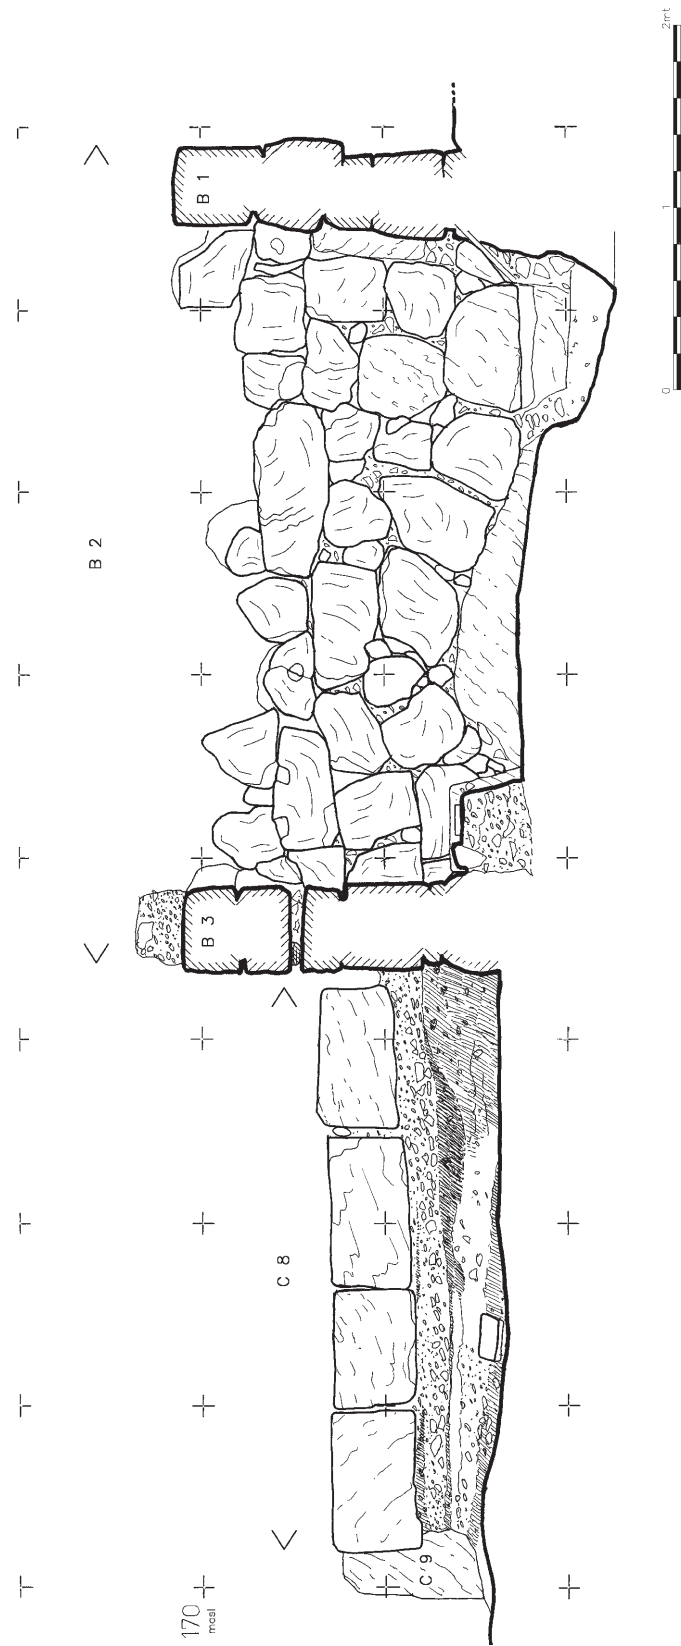
Plate 11. Section L16. View from the west of elevation of wall C8, through wall B3, elevation of wall B2, through wall B1.

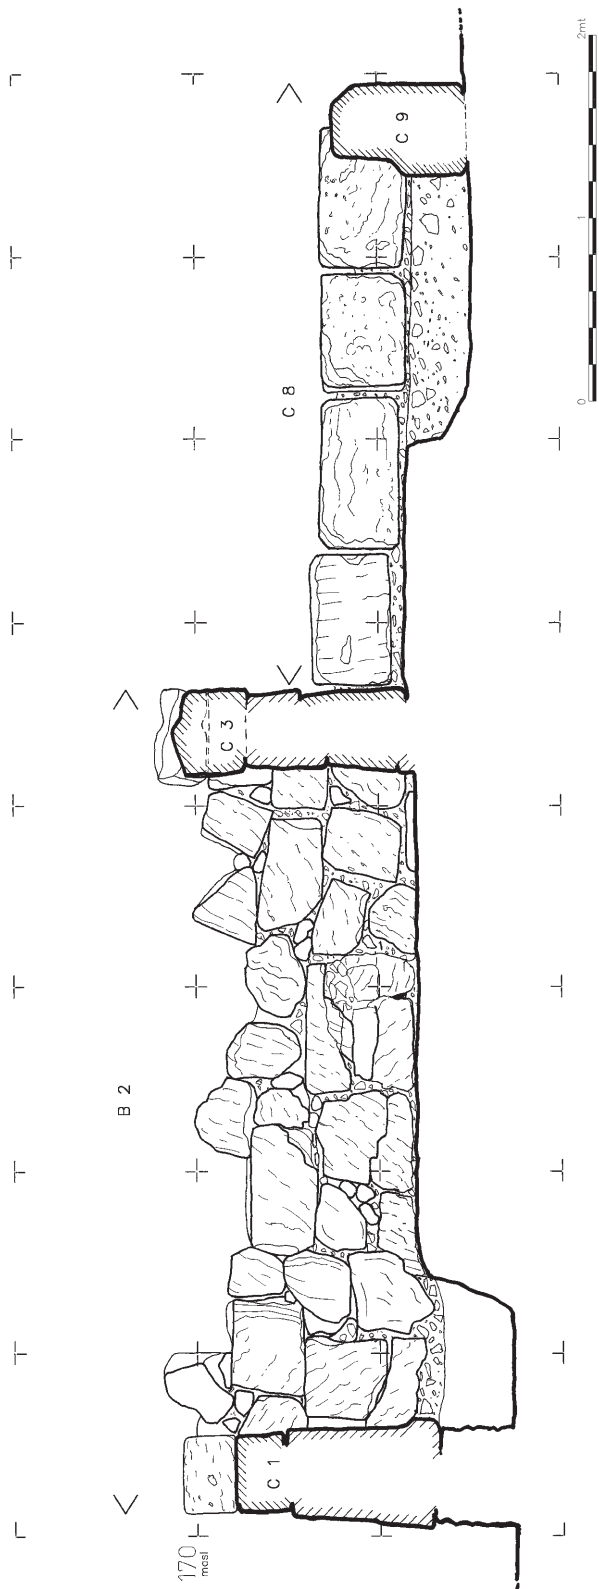
Plate 12. Section L17. View from the east through wall C1, elevation of B2, through wall C3, elevation of wall C8, through wall C9.

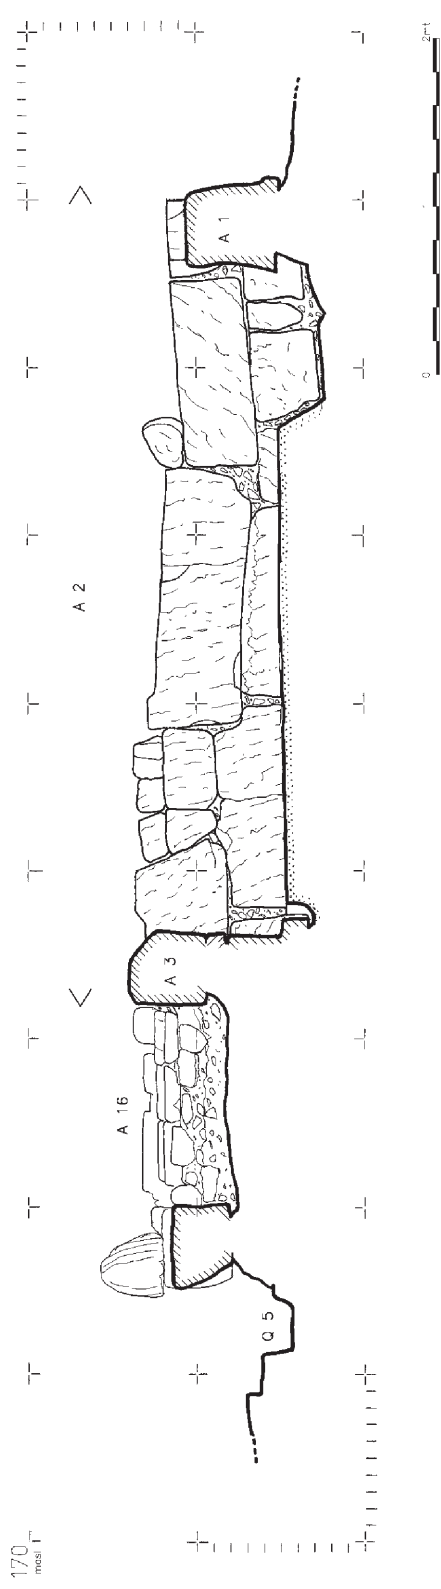
Plate 13. Section L22. View from the west through canal Q5, wall A15, elevation of wall A16, through wall A3, elevation of wall A2, through wall A1.

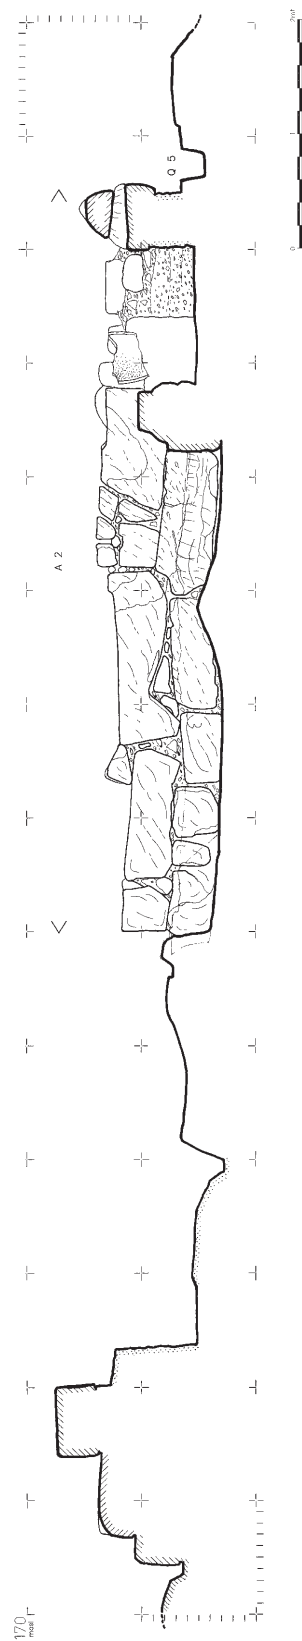
Plate 14. Section L23. View from the east through wall L3, yard Ad, elevation of wall A2, through wall A16, through wall A15, canal Q5.

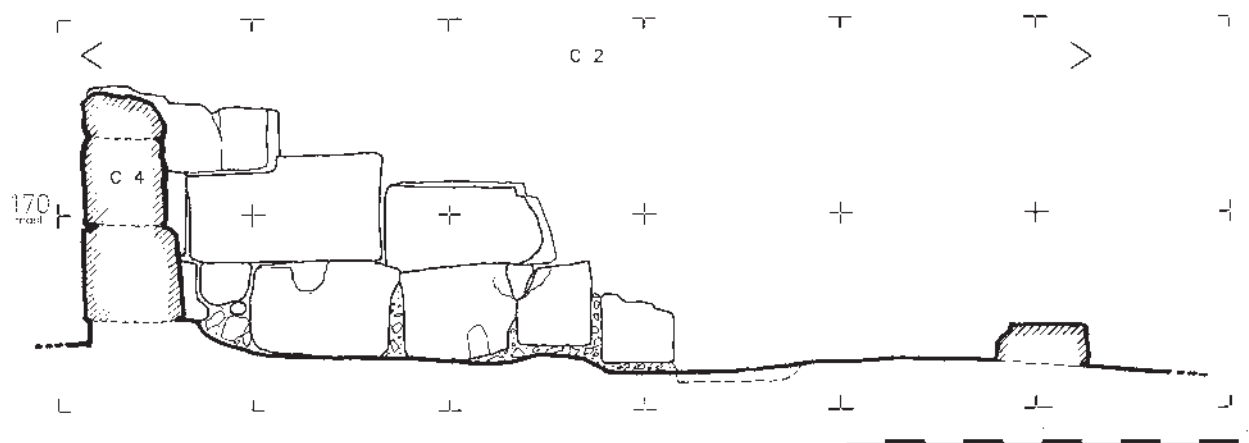
Plate 15. Section L25. View from the east through wall C4 and elevation of wall C2.

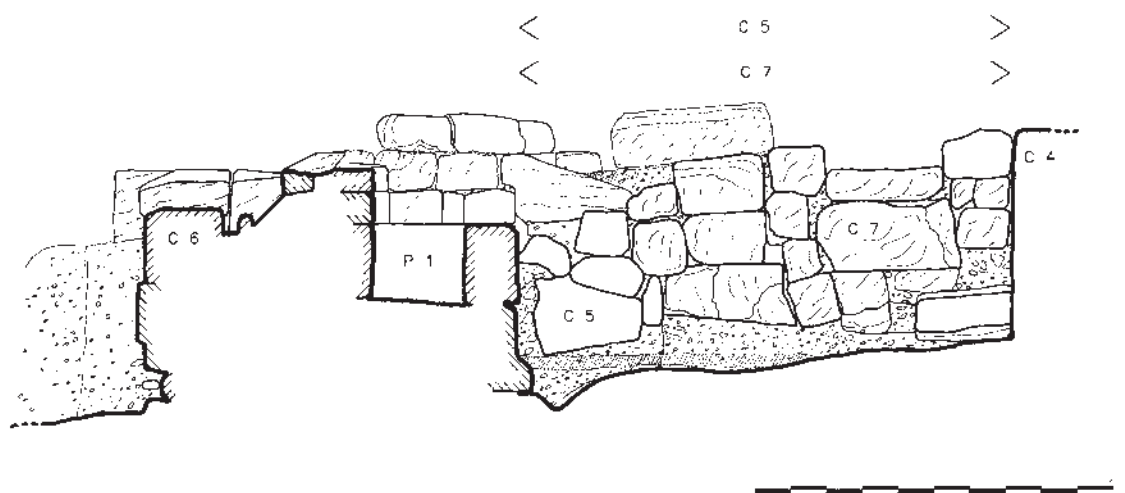
Plate 16. Section L29. View from the west through wall C6, Well P1, elevation of wall C7.

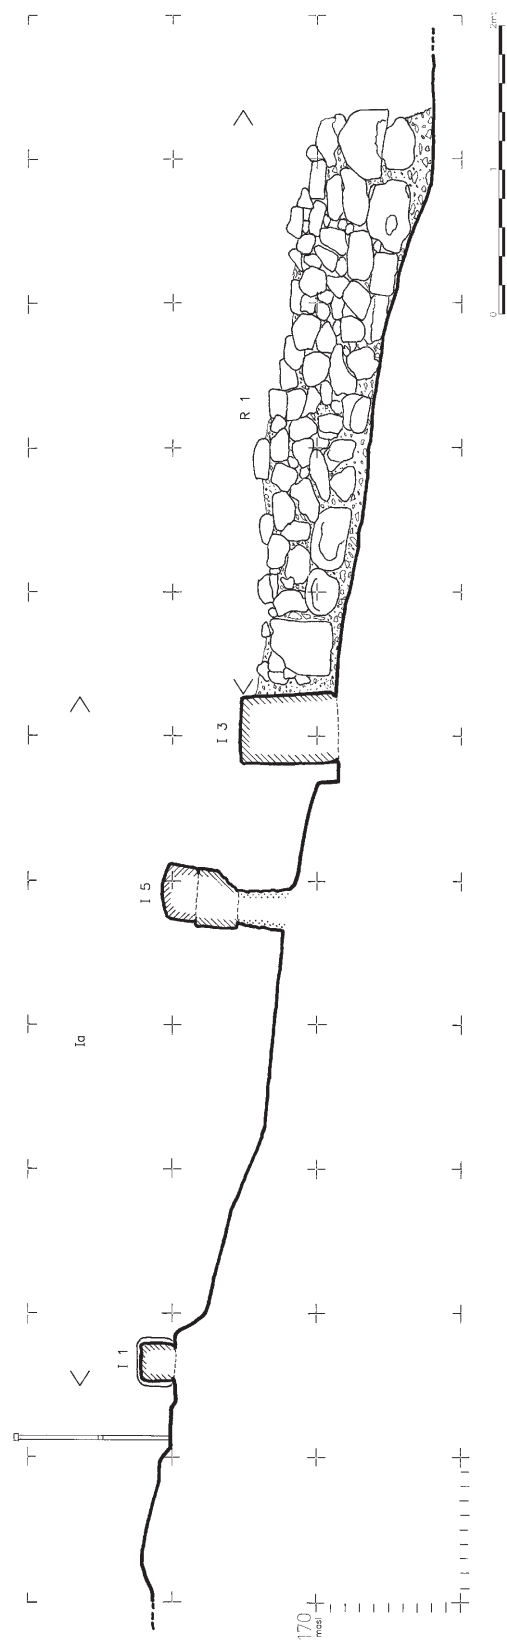
Plate 17. Section L31. View from the east through walls I 15-I3, elevation R1.

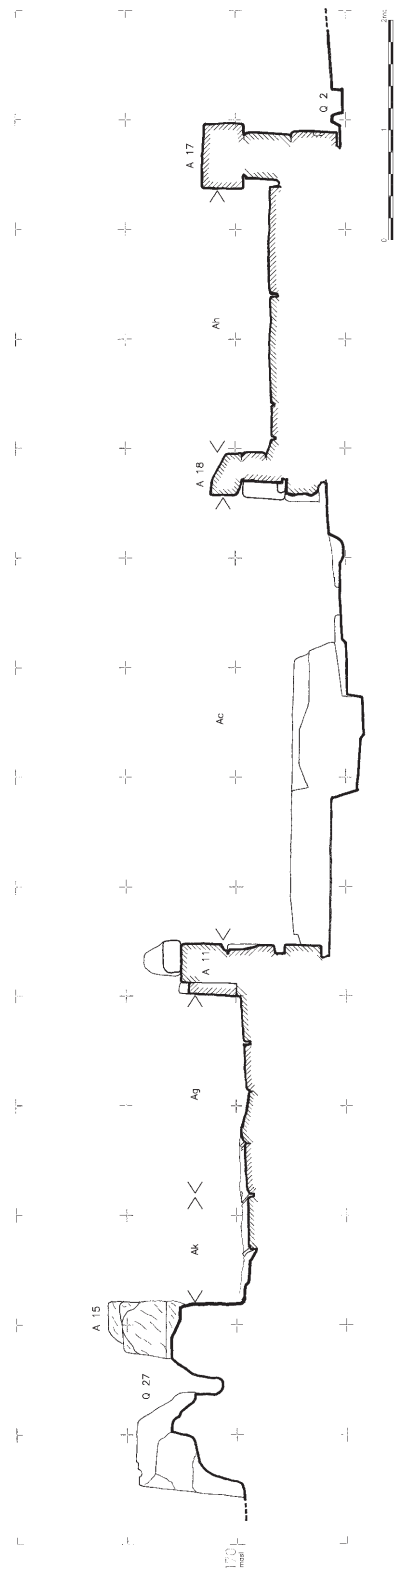
Plate 18. Section L32. View from the west through canal Q27, wall A15, niches Ak-Ag, wall A11, yard Ac, wall A18, niche Ah, wall A17, canal Q2.

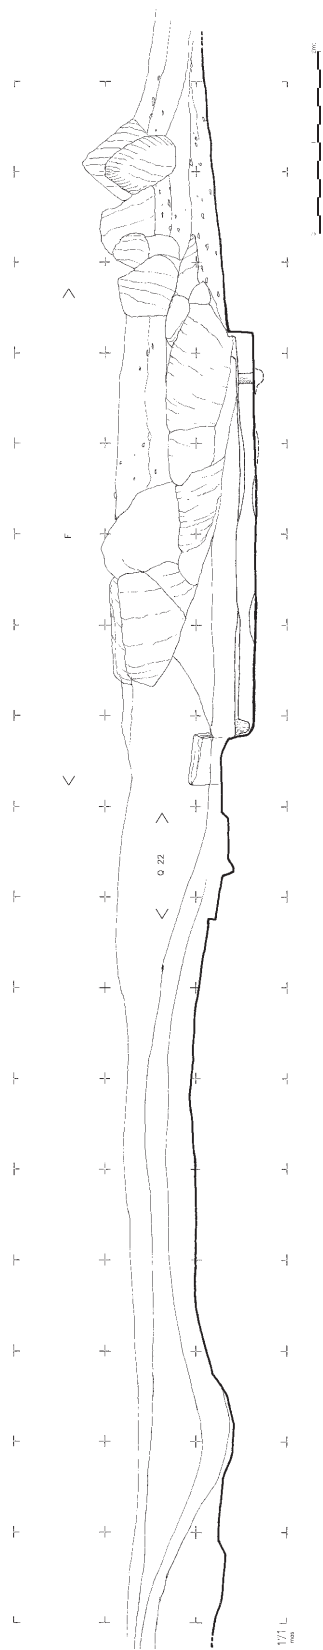
Plate 19. Section L38. View from the west towards rock De, through Q22, House F.

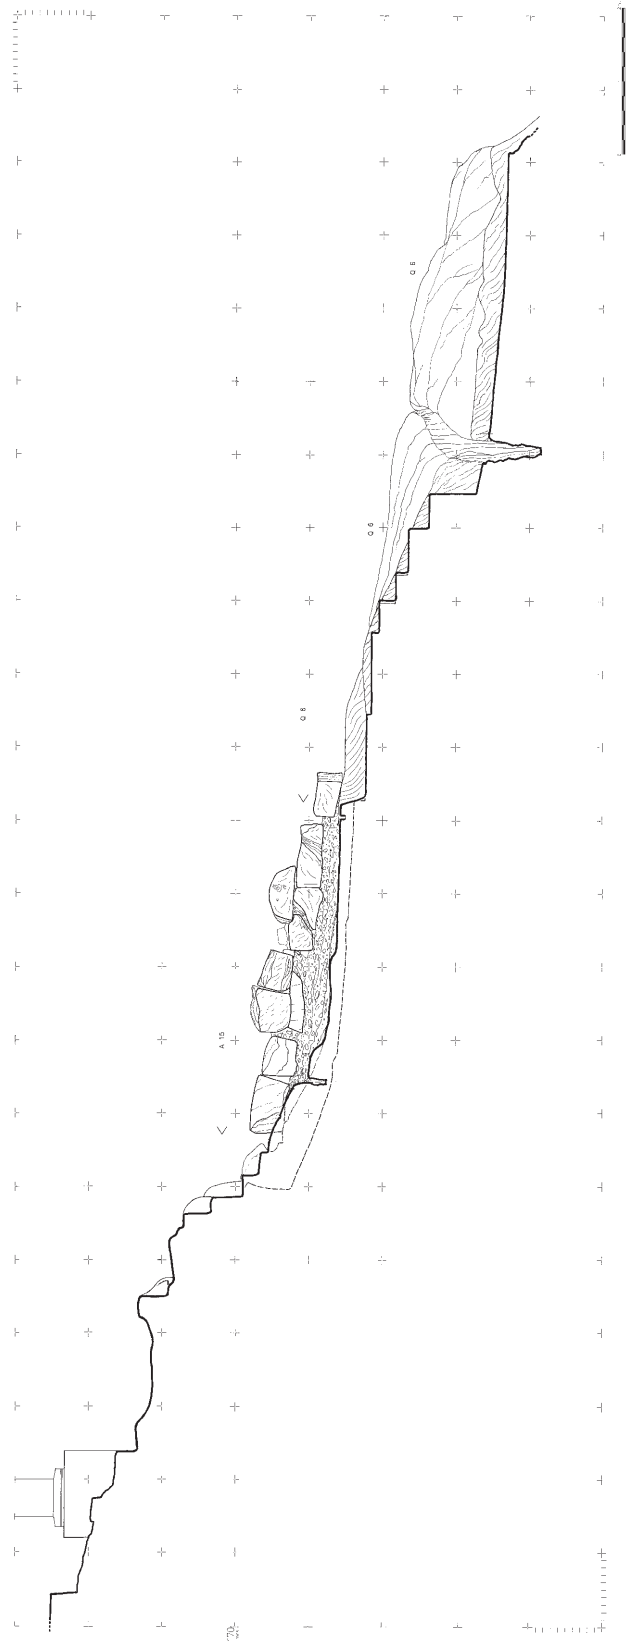
Plate 20. Section T2. View from the north of wall A15 and canal Q6.

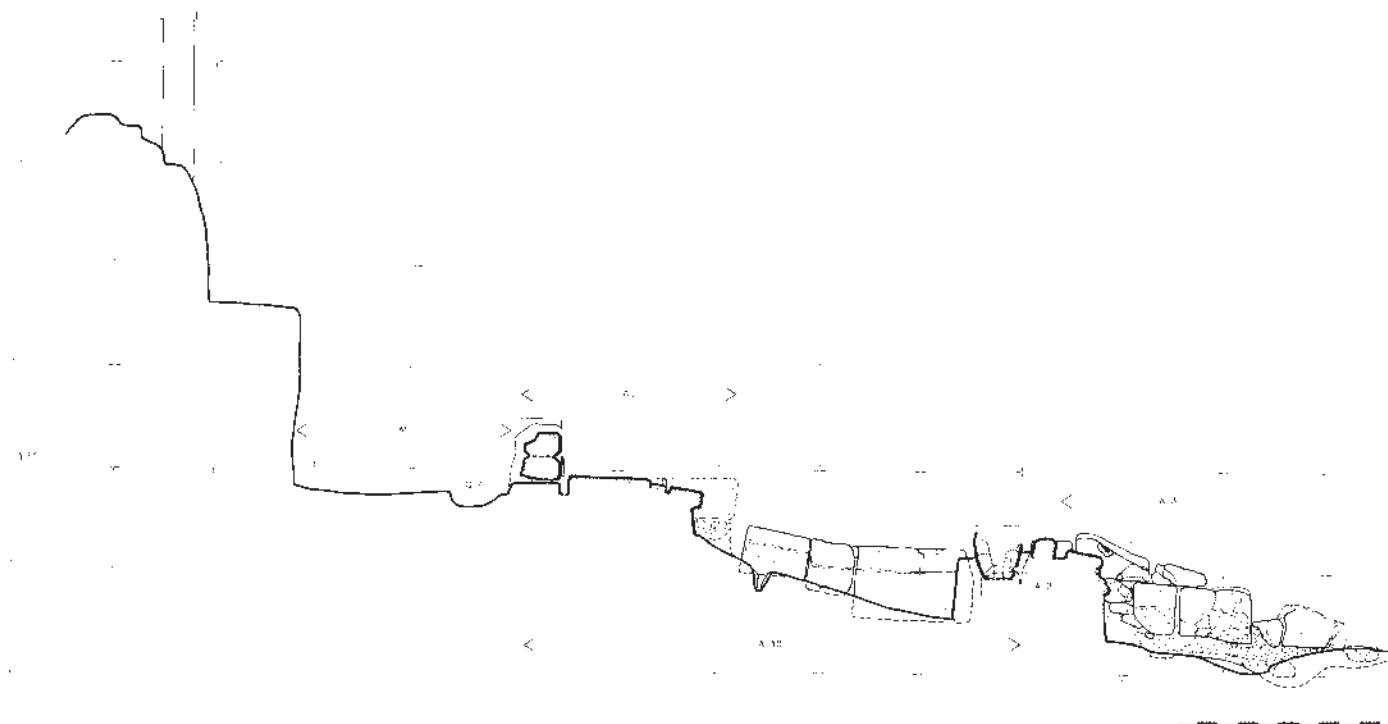
Plate 21. Section T4. View from the north through niche Ag, canal Q4, niche Af, and elevations of walls A10-A3.

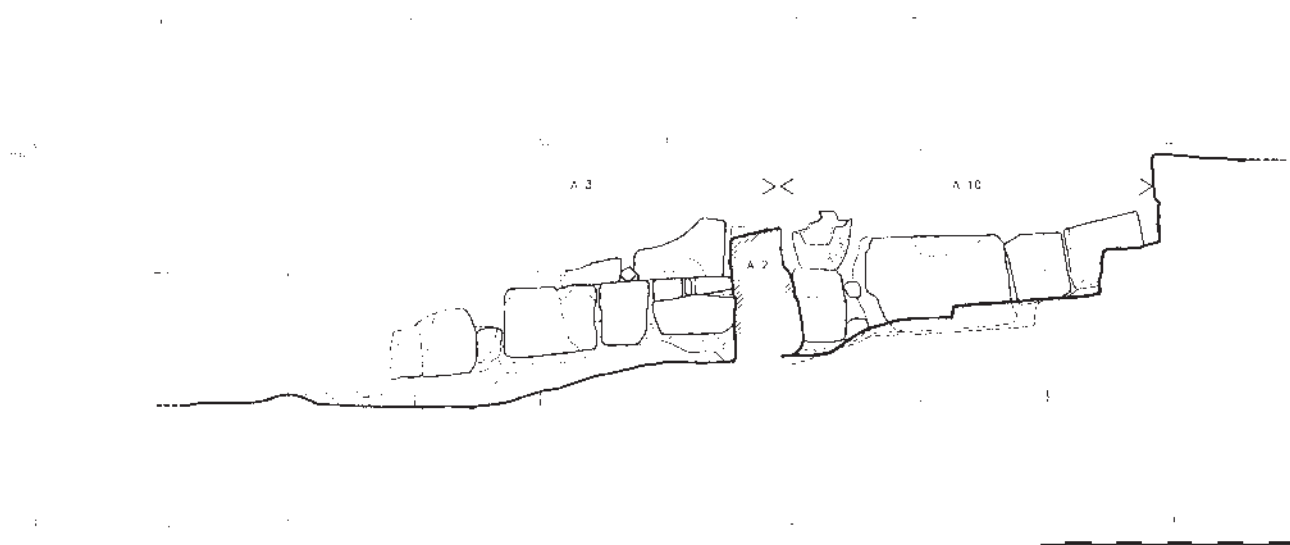
Plate 22. Section T5. View from the south of walls A3-A10 and through wall A2.

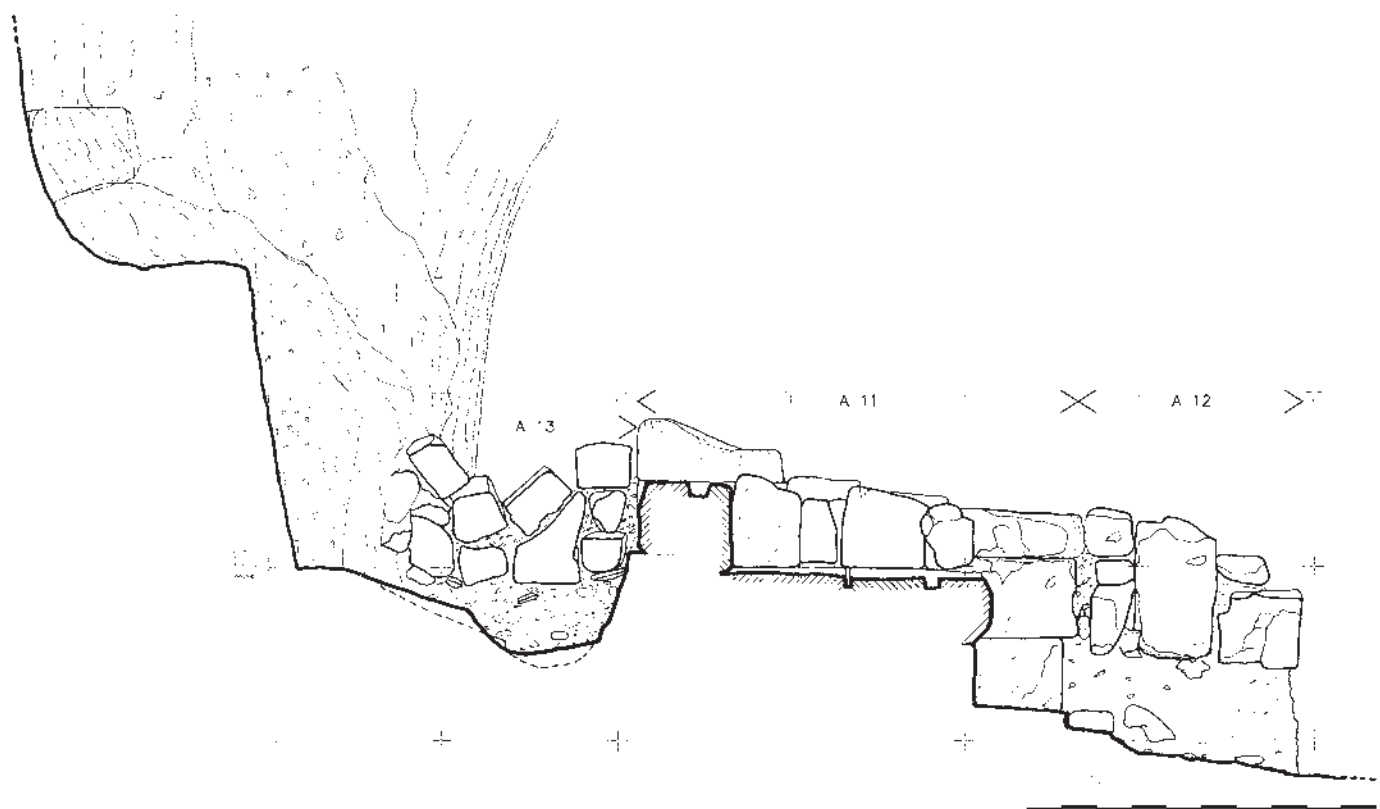
Plate 23. Section T6. View from the north of walls A13-A11-A12.

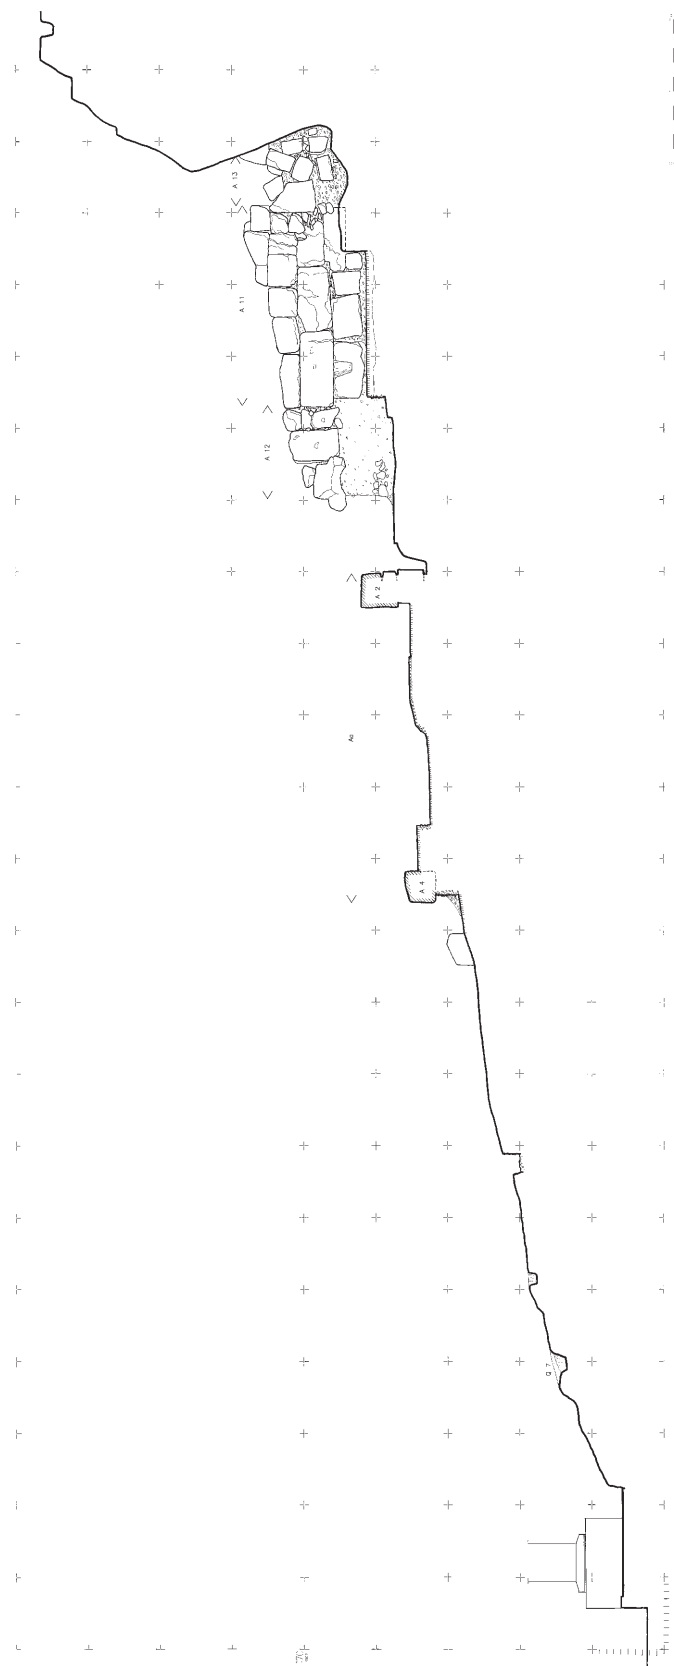
Plate 24. Section T7. View from the south of through Q7, rock Na, rooms Ab-Aa, through walls A4-A2, work area Ac and elevations of walls A12-A11-A13.

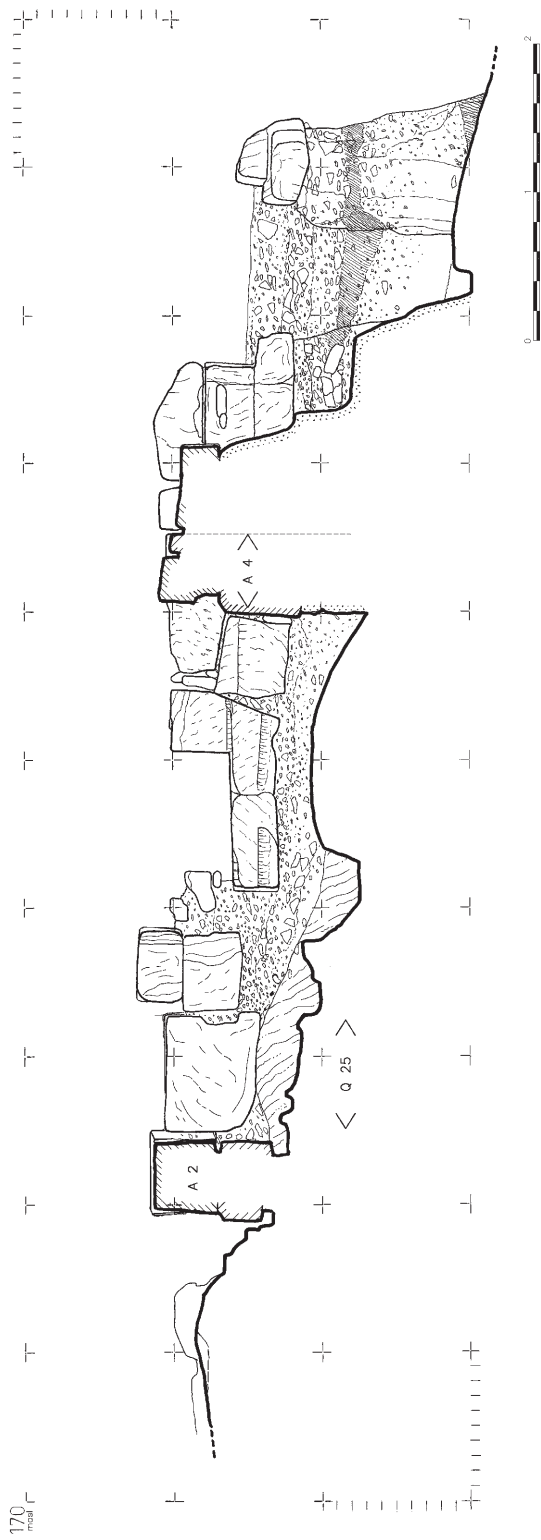
Plate 25. Section T8. View from the north through walls A2-A4, elevations of walls A1-A7.

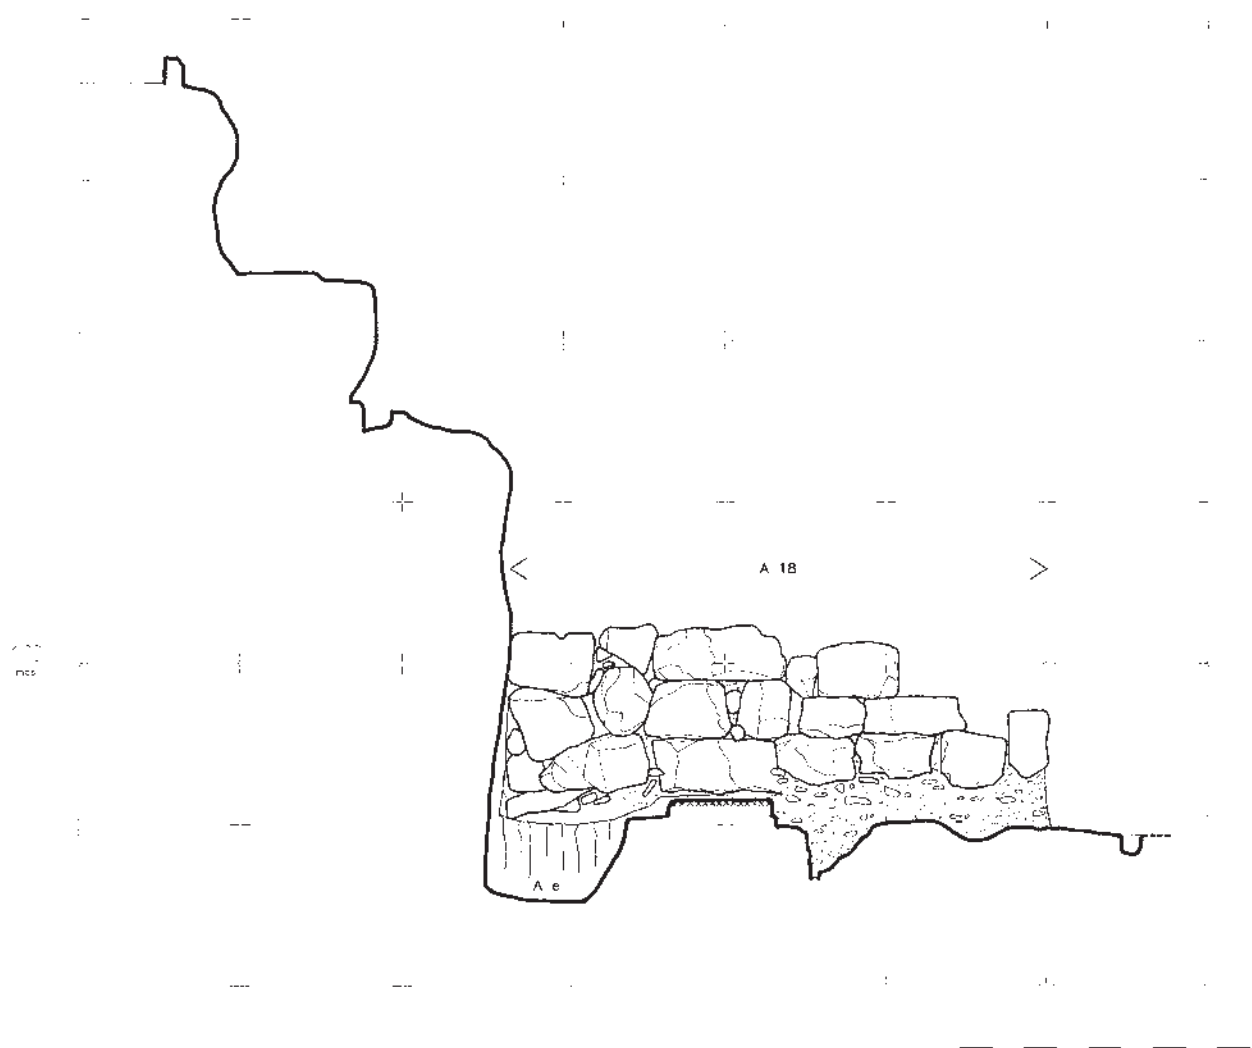
Plate 27. Section T10. View from the north of wall A18.
