Plate 1. Archaeological masonry plan of the area without letters.

Plate 2. Photographic montage of Borgos NW of images from the photographic tower, *la giraffa*, by B. Blomé (1961–1963).

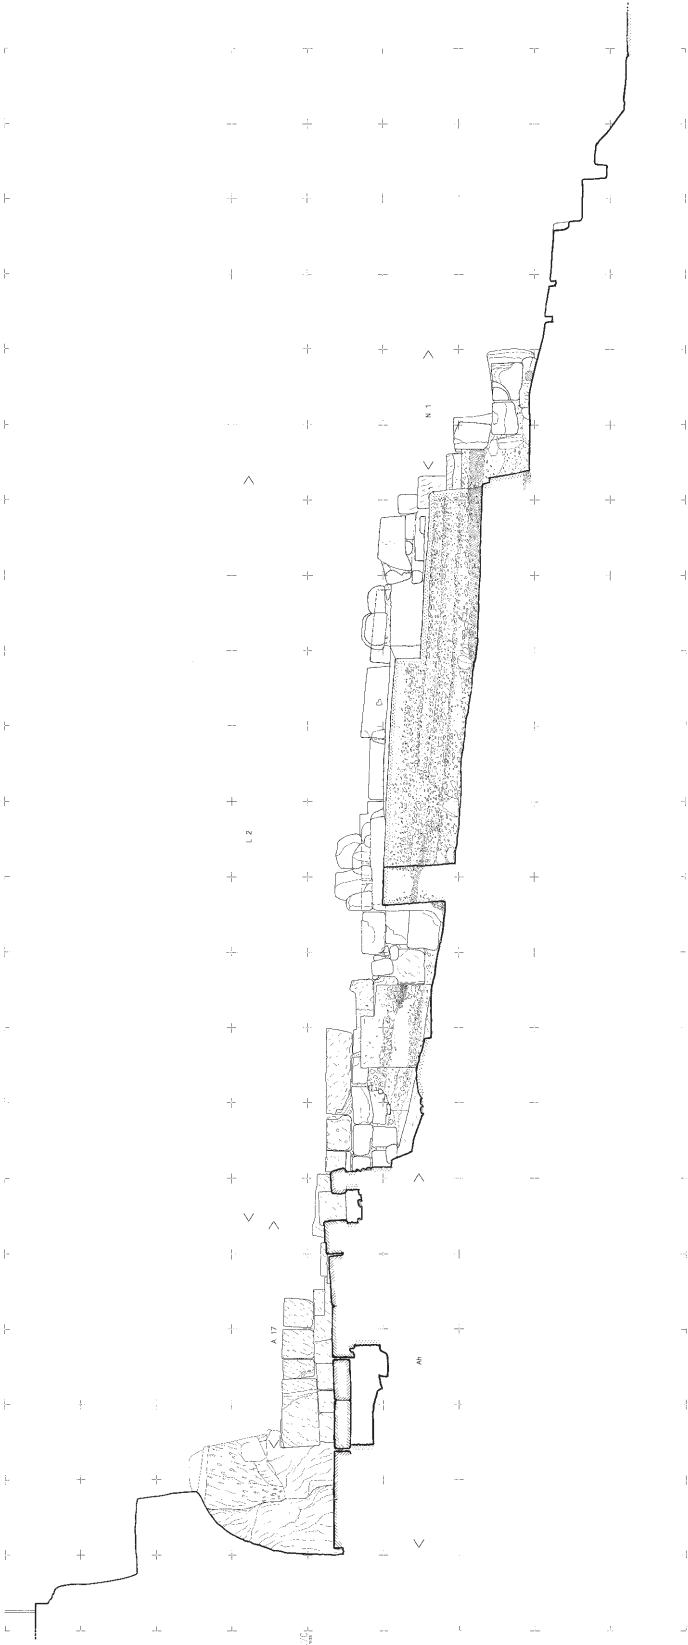
Plate 28. Section T12. View from the north through niche Ah, yard Ad, elevations of walls A17-L2-L3-N1.

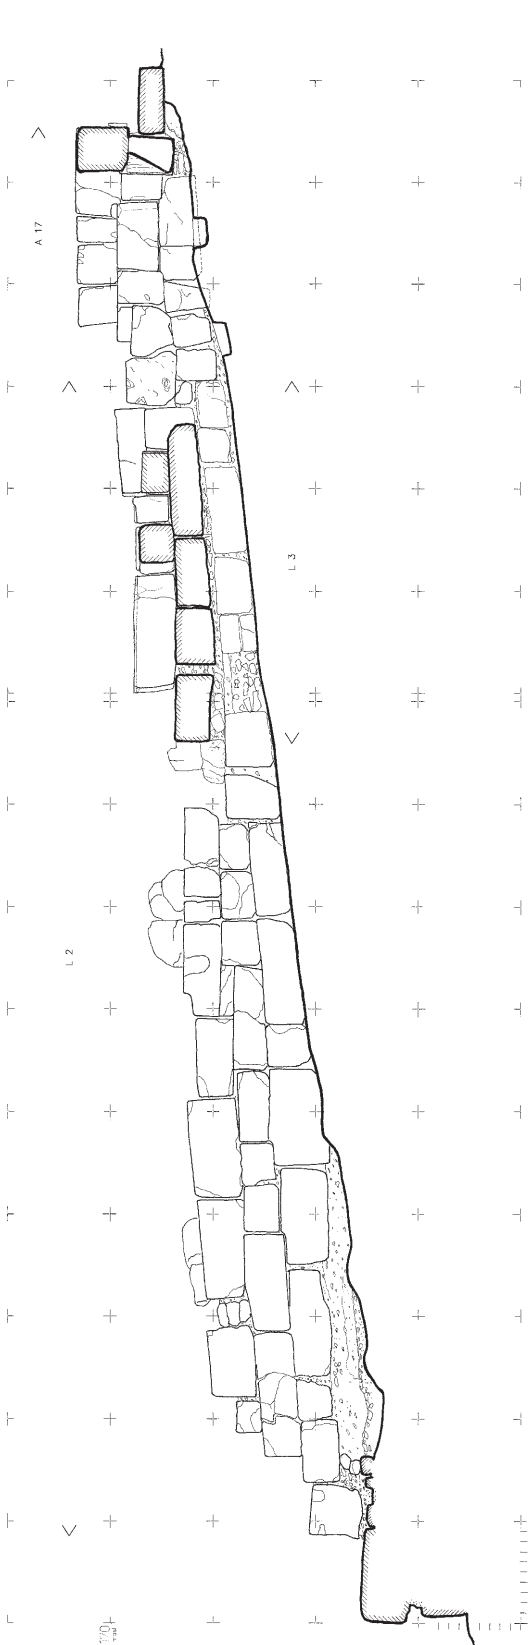
Plate 29. Section T13. View from the south of walls L2-L3-A17.

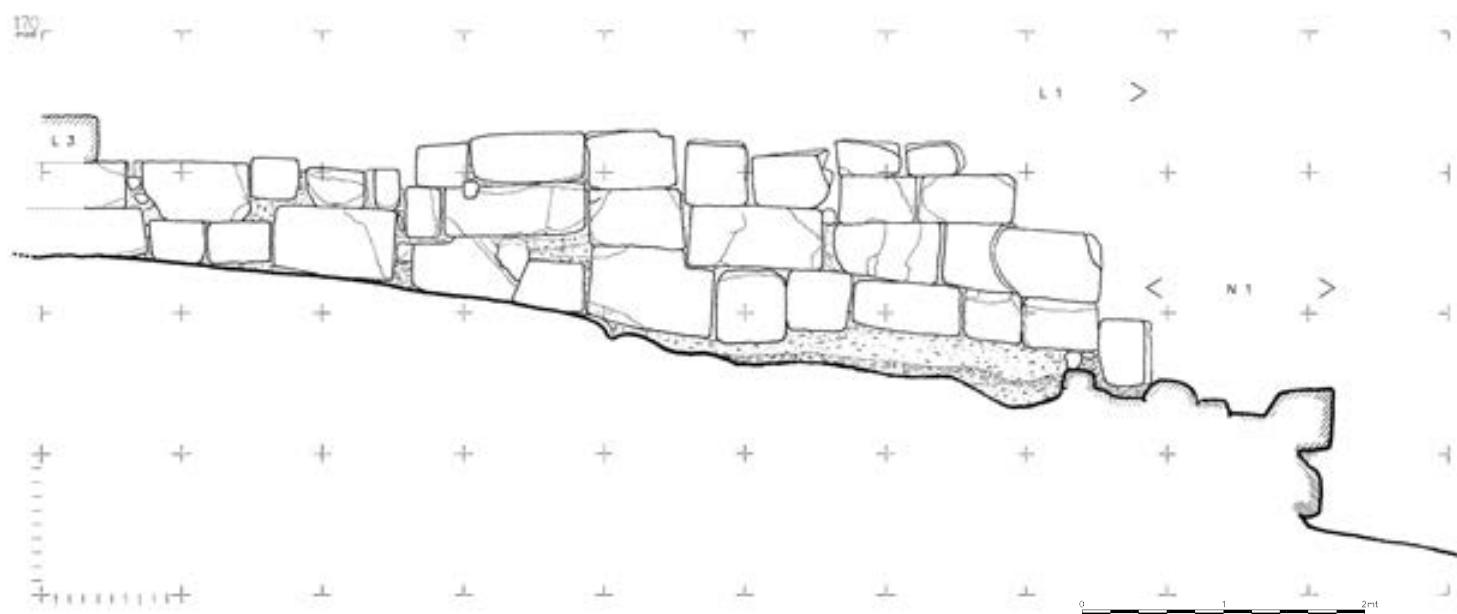
Plate 30. Section T14. View from the north of walls L3-L1-N1.

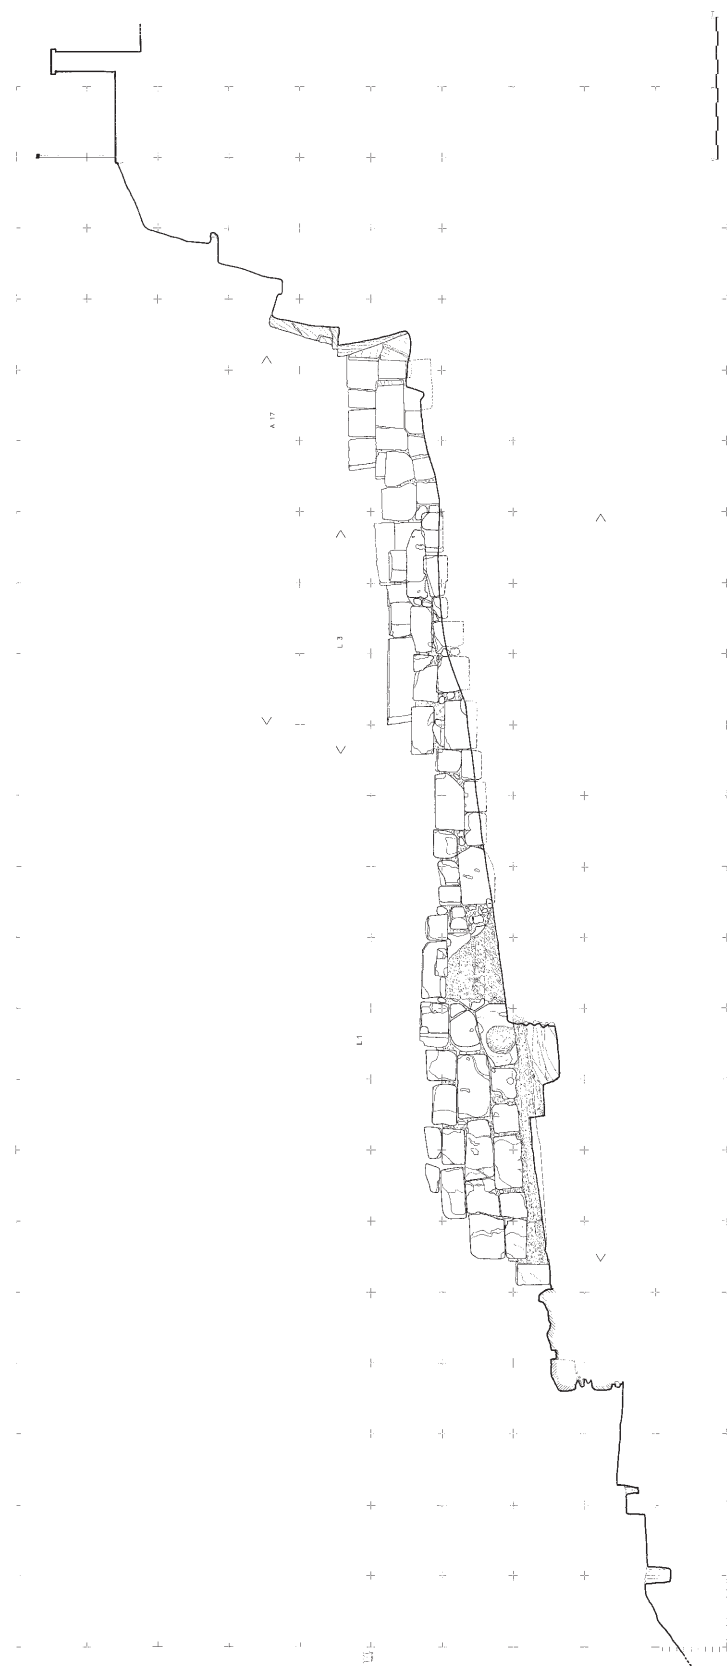
Plate 31. Section T15. View from the south of canal Q8, walls N1-L1-L3-A17, cutting Q23.

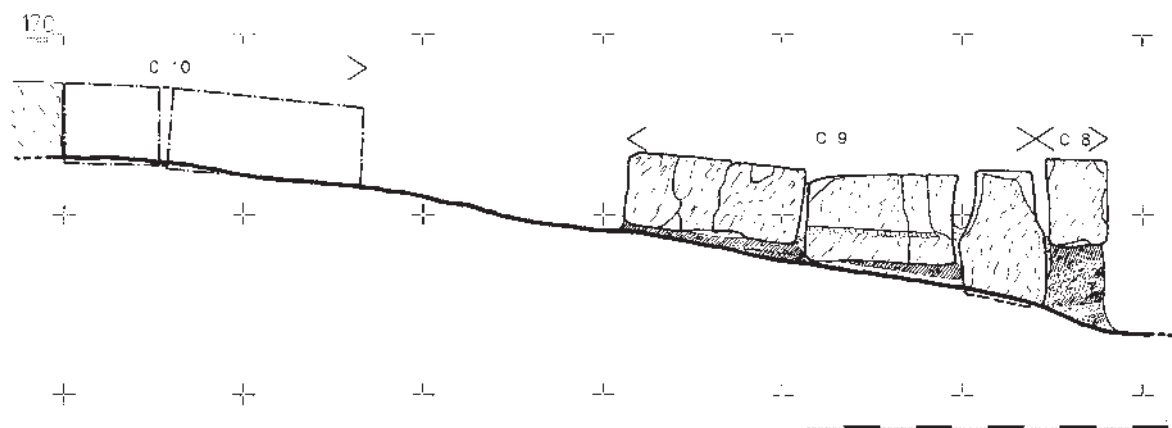
Plate 32. Section T16. View from the north of walls C10-C9, through C8.

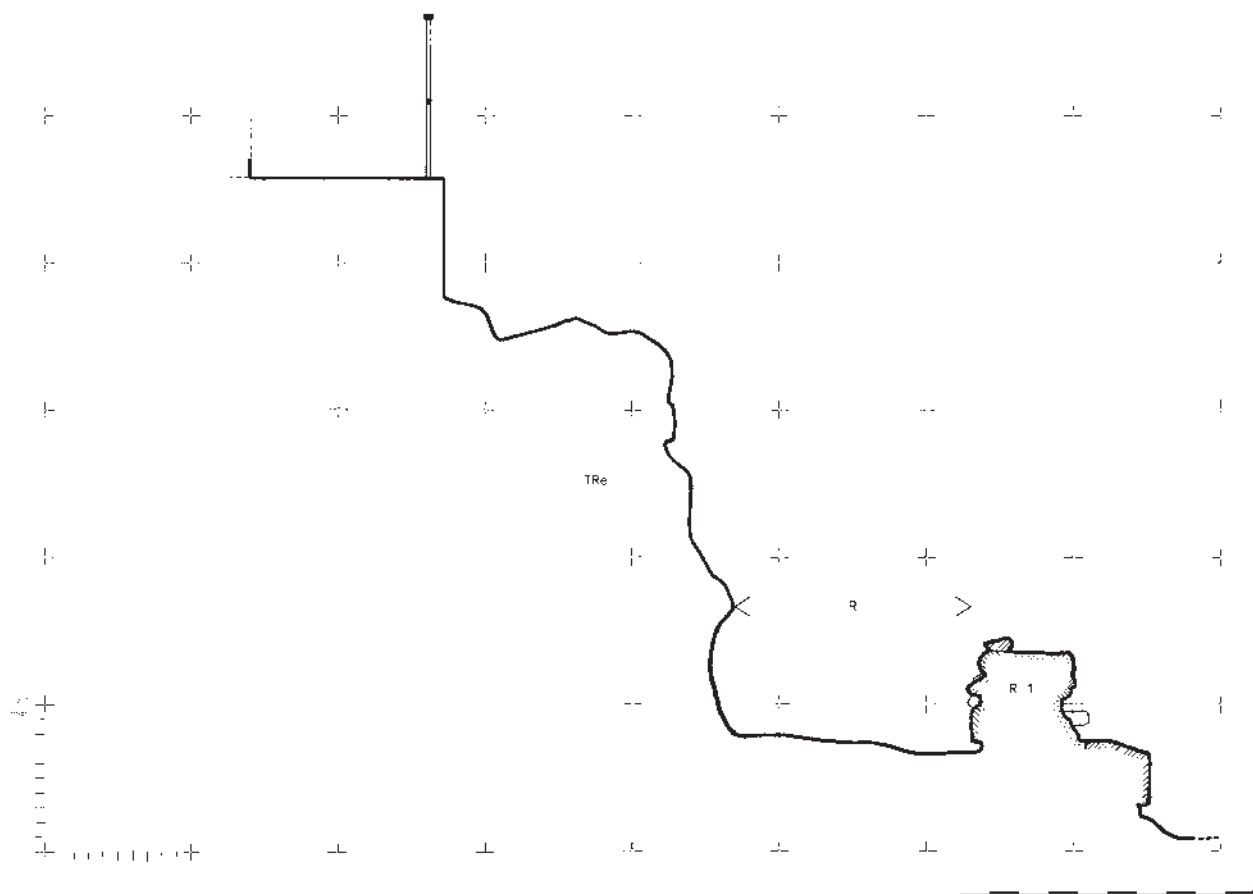
Plate 33. Section T18. View from the north through rock TRe, through wall R1.

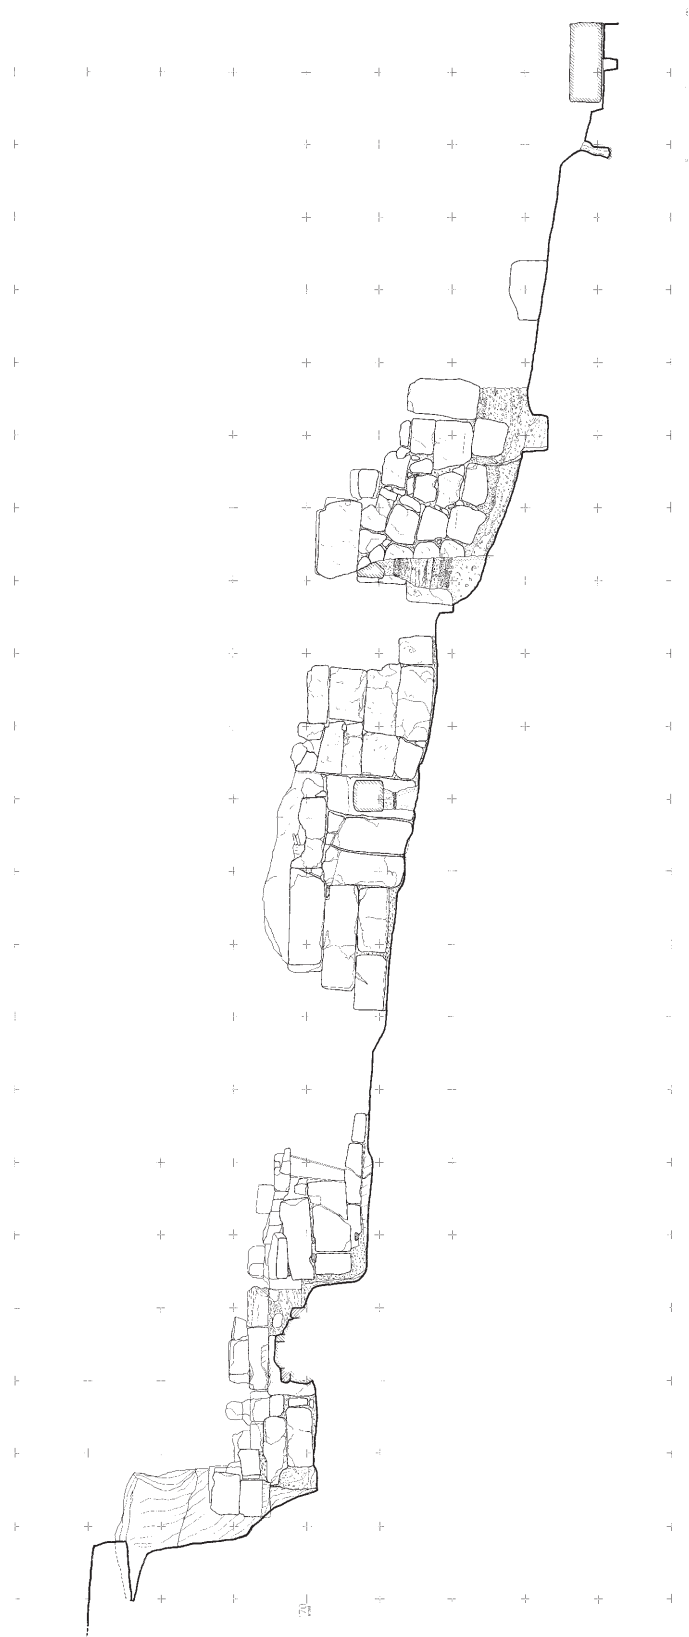
Plate 34. Section T19. View from the north of walls I3-C6-C3-B3-B5-Nb-Mc.

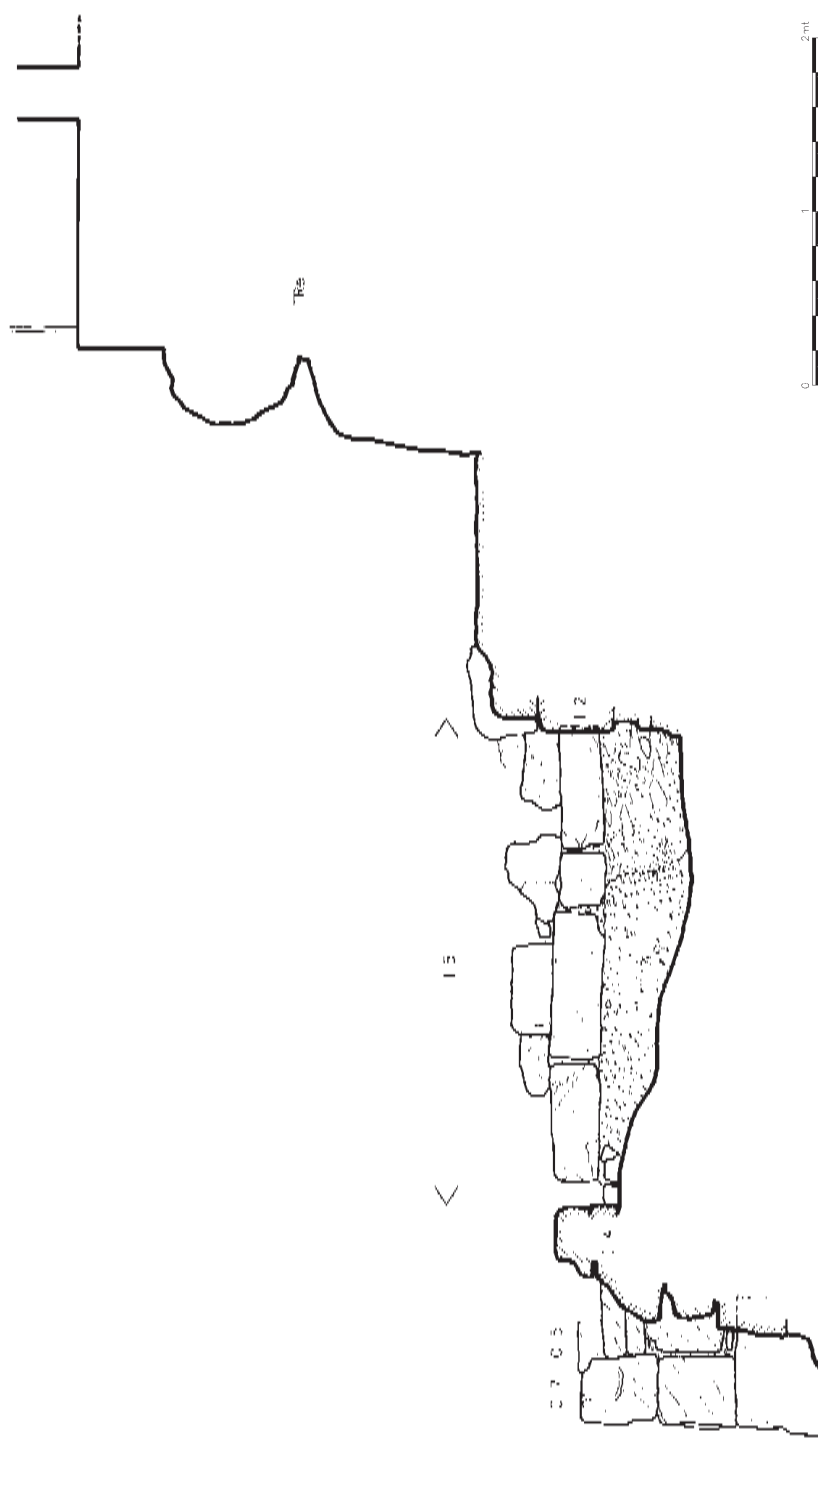
Plate 35. Section T24. View from the south through walls C7-C5-14, elevation of wall I5, through wall I2.

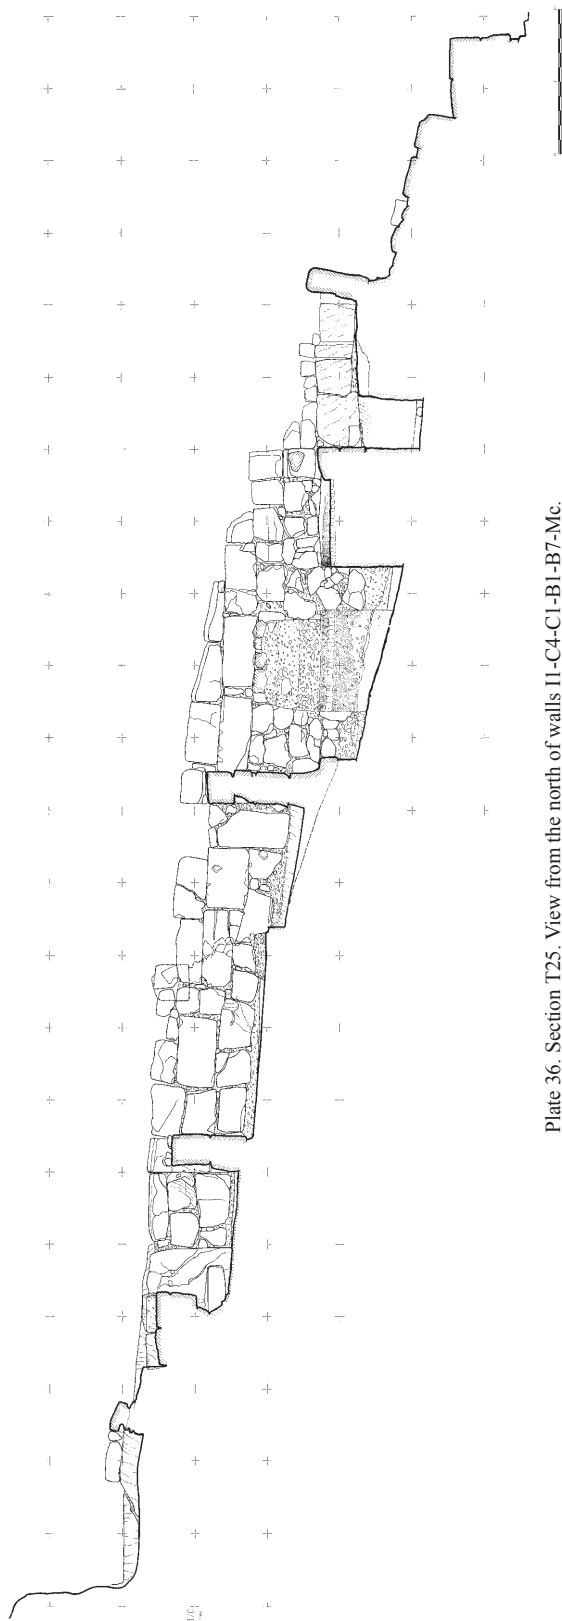
Plate 36. Section T25. View from the north of walls II-C4-C1-B1-B7-Mc.

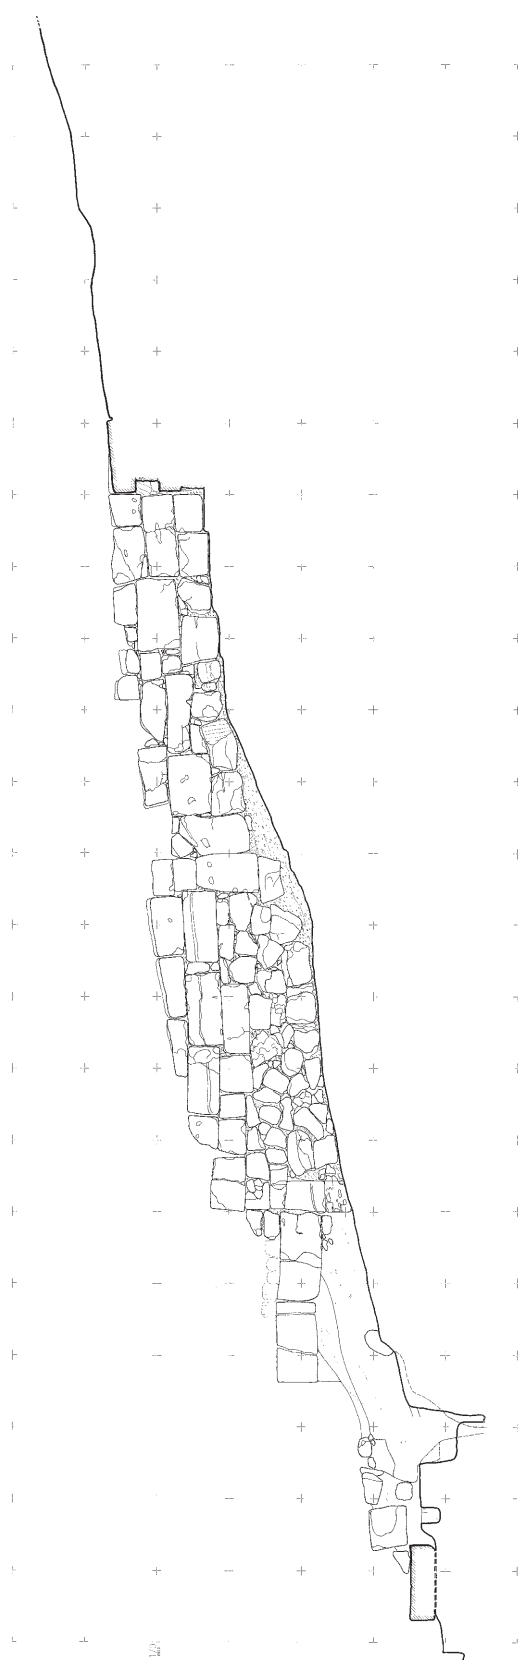
Plate 37. Section T26. View from the south of walls Mc-B7-B1-C1-C4.

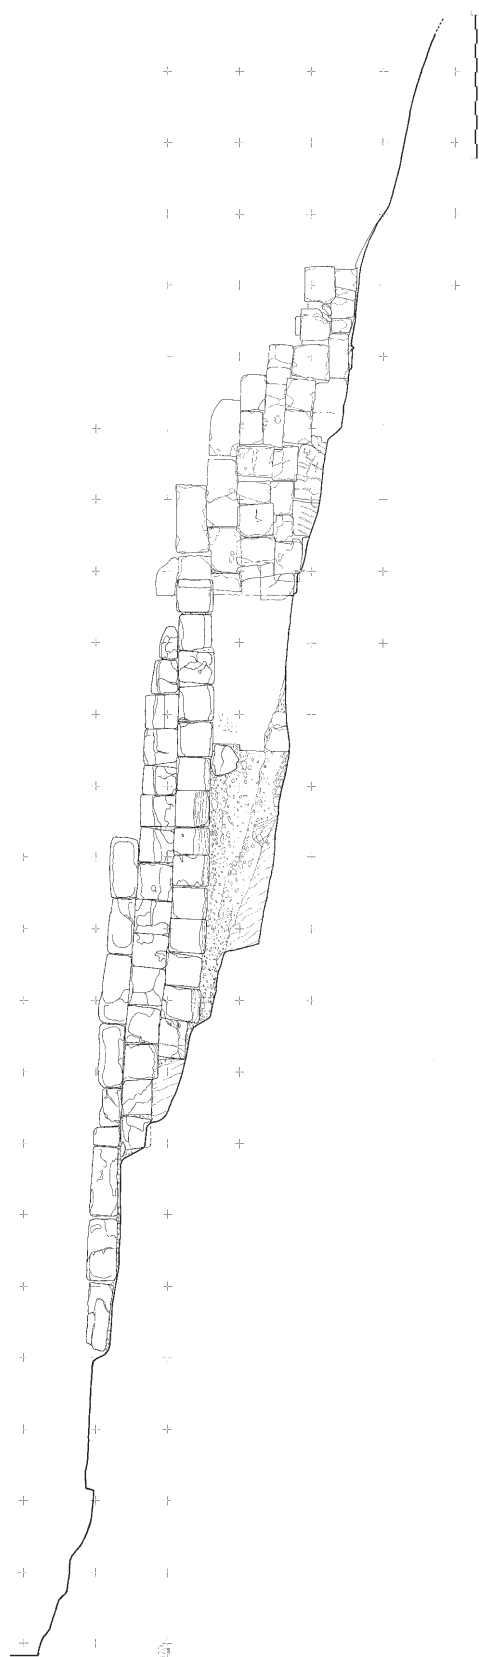
Plate 38a. Section T27a. View from the north of canal Q14 and walls K3-K2, D3.

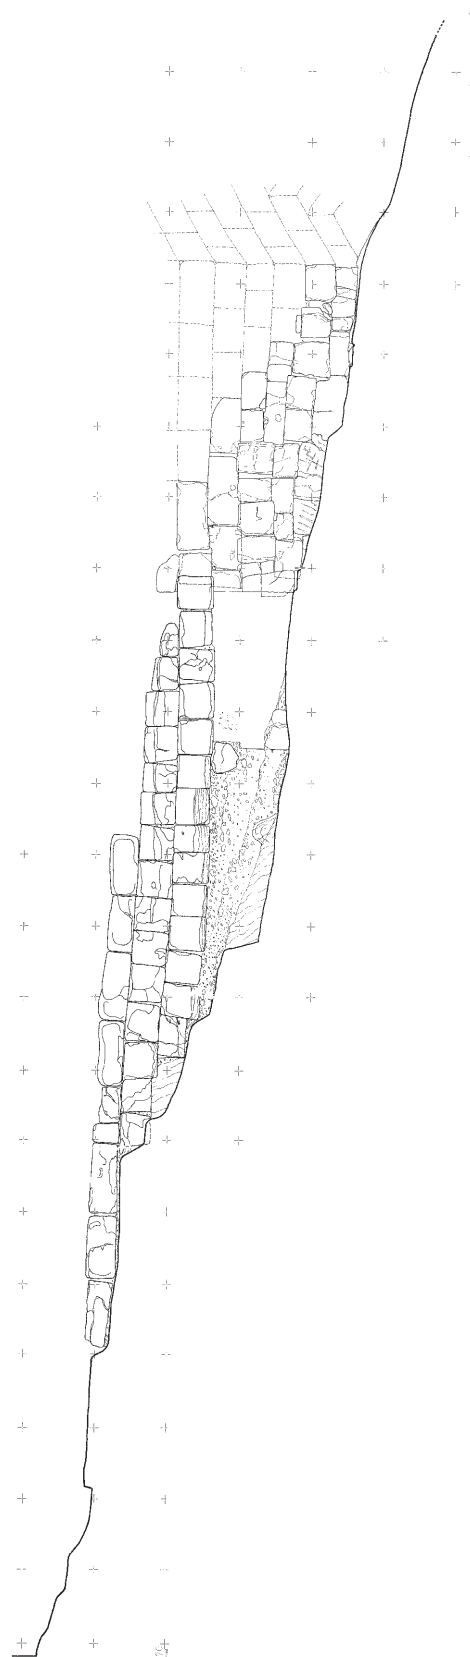
Plate 38b. Section T27b. The same with reconstruction.

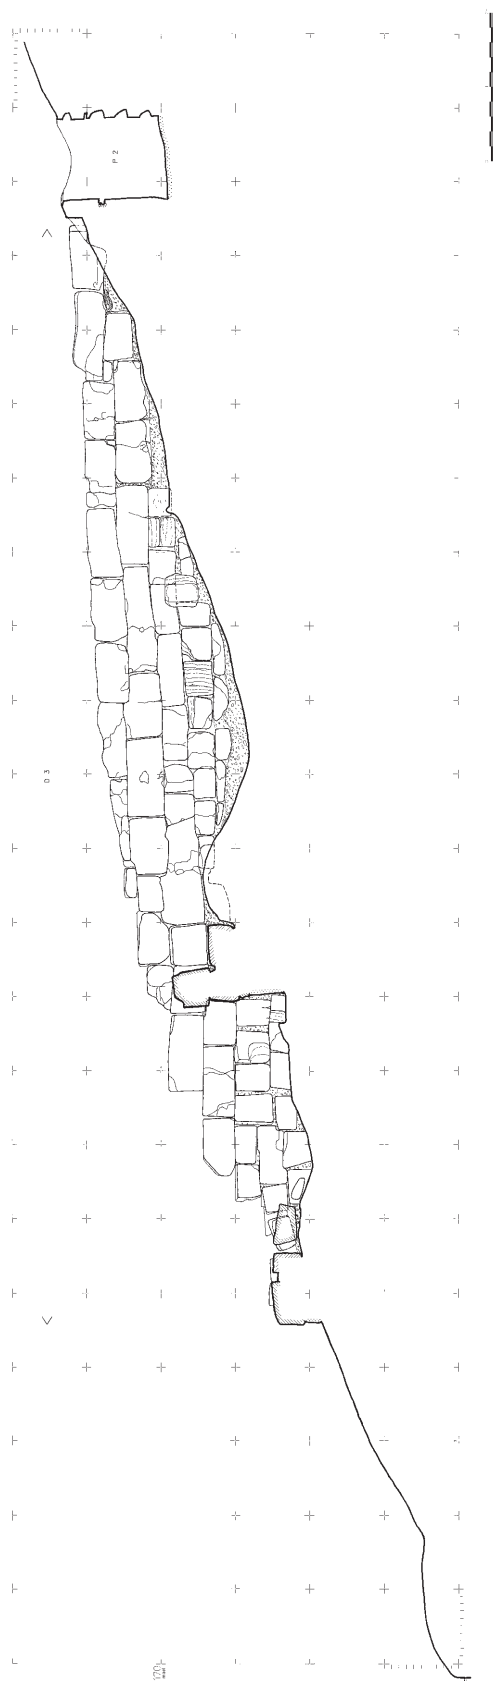
Plate 39. Section T28. View from the south of wall D3 and through the upper part of Well P2.

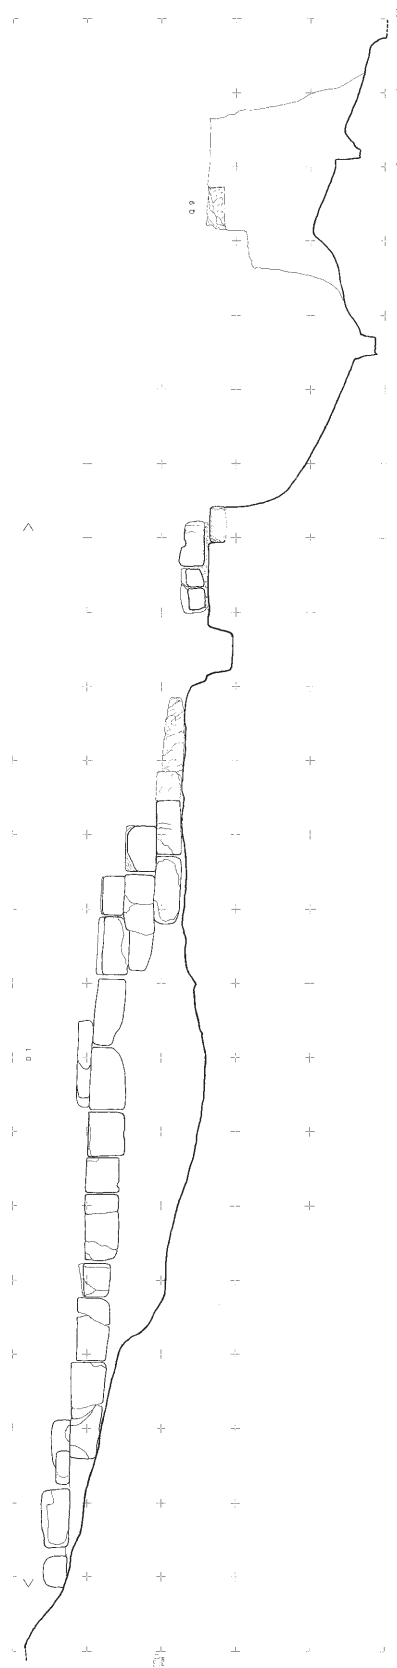
Plate 40. Section T31. View from the north of wall D1, through canals Q11-Q9.

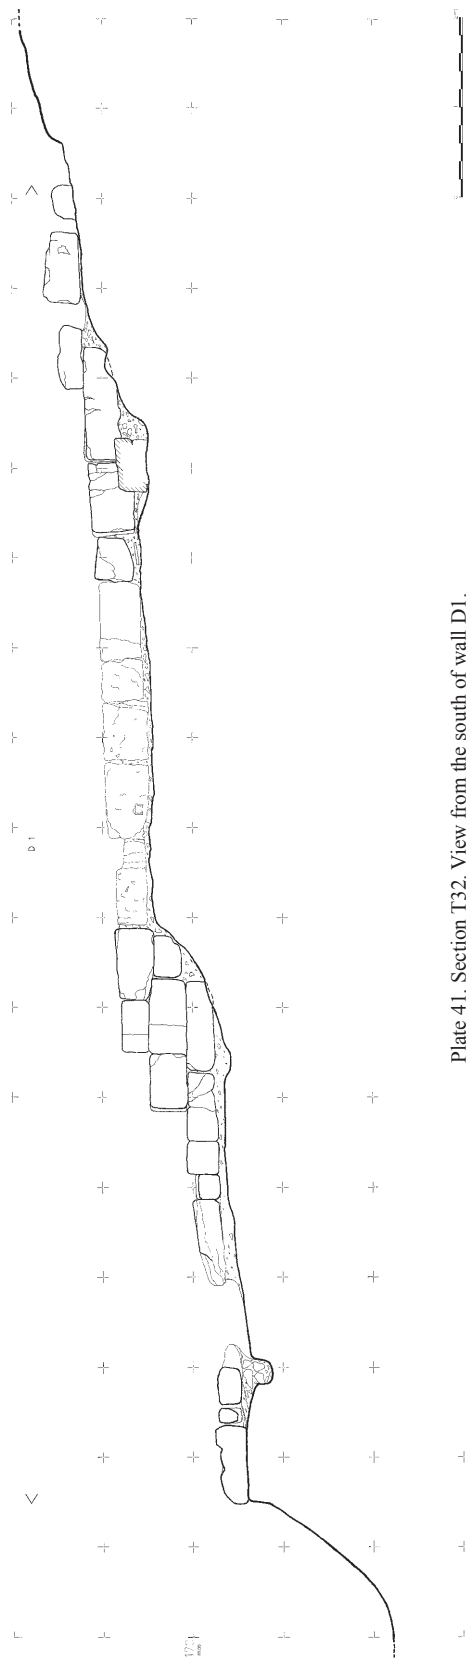
Plate 41. Section T32. View from the south of wall D1.

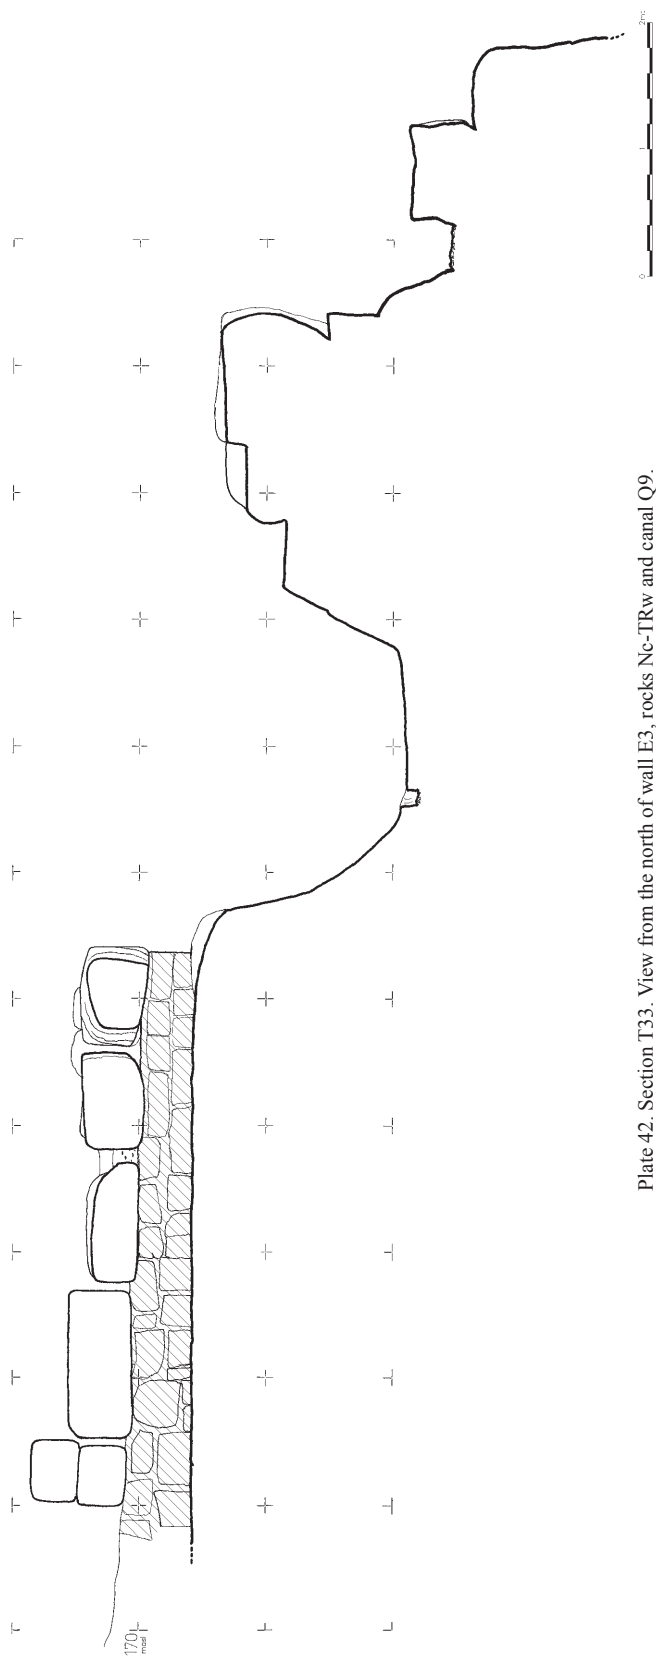
Plate 42. Section T33. View from the north of wall E3, rocks Nc-TRw and canal Q9.

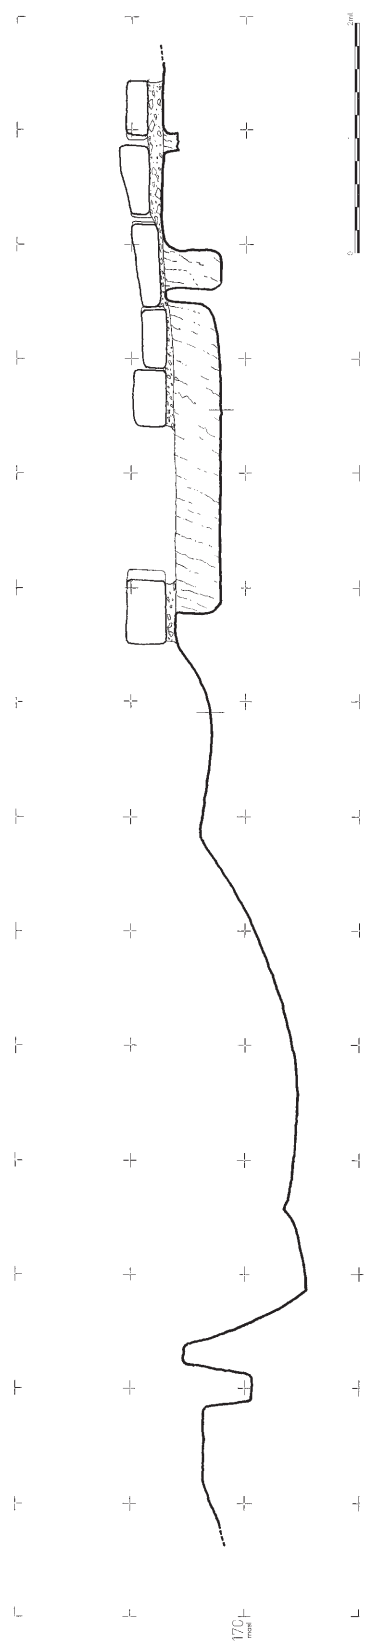
Plate 43. Section T36. View from the south of canal Q10, wall D8.
