The water-mills on the Lamas River in Cilicia

A water-mill establishment on the Lamas River in Cilicia was reported by travellers in the 19th century. It consisted of a series of parallel, horizontal-wheeled mills along an oblique rock face. It was the subject of examination in 1990 and a brief publication shortly afterwards. Due to its interesting and rather rare construction a more thorough publication is given here.

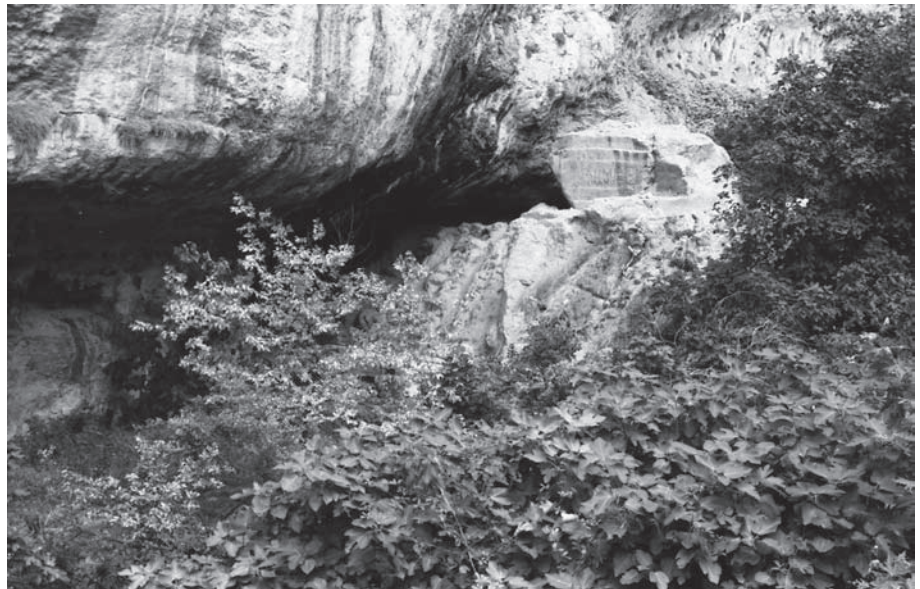
Fig. 3. The river, including the perpendicular western side with part of the gallery.

2).⁸ On the western side, the cliff is high and almost perpendicular (*Fig. 3*), and at certain points an aqueduct, in the form of a gallery cut into the rock, is visible.⁹ In fact, it is a rather dangerous place and already the following year I noticed big boulders which had fallen down from above.

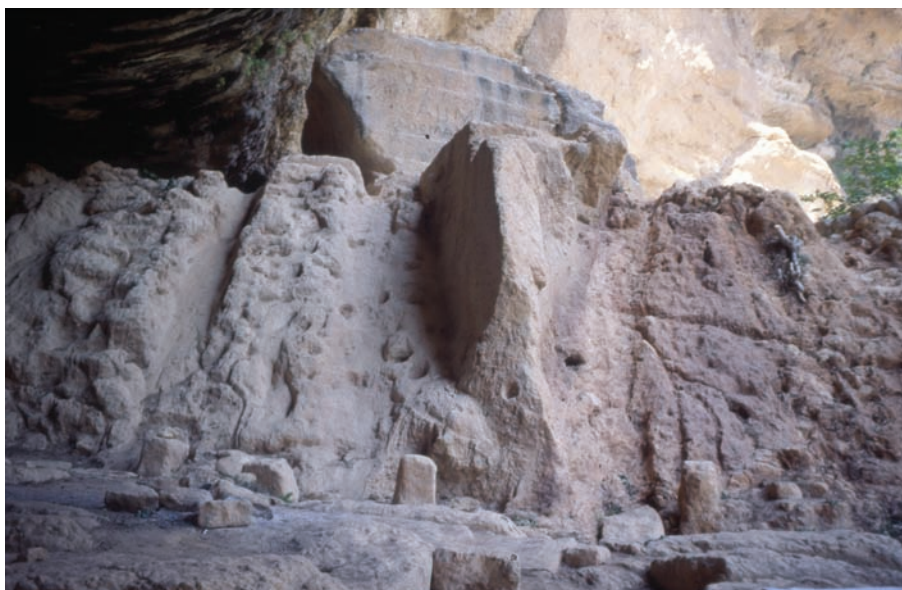
Fig. 4. The cliff with the spur, surrounded by grooves, and a niche in the lower part.

5.5 m wide at the SE end and 3 m high. It seems to have been the object of cutting activity, perhaps for cutting some of the blocks used for the floor mentioned below; in fact, the pattern of rectangles seen on the façade in *Figs. 2* and *4* are no doubt traces of this cutting activity. The mill-race has been divided into two channels, running on either side of the cliff and continuing to a precipice of a cliff, about 5 m high and sloping of ca 45°. ¹⁰ In the middle of it is a projecting spur along its whole height and about 50 cm wide (*Fig. 4*). In the south

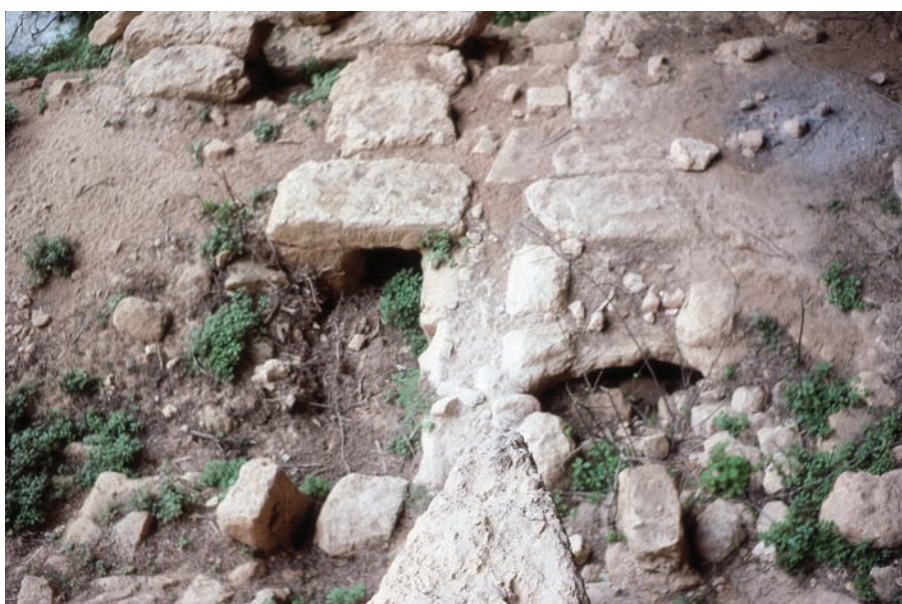
Fig. 5. The NW tunnel ends seen from the cliff.

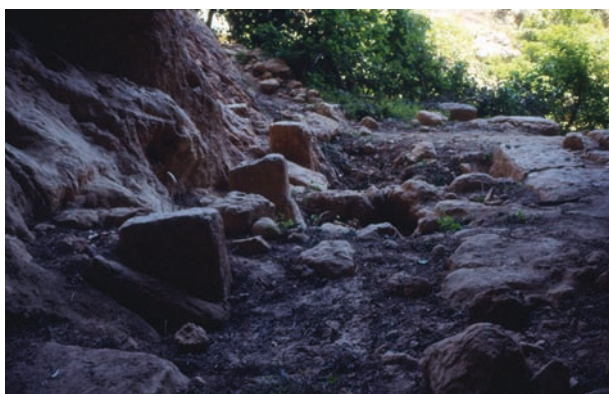
Fig. 6. The line of cones below the cliff.

standing between the cliff and the floor (Fig. 6, see below).¹² The SE end of the floor has a marked edge, with an irregular staircase leading down to the ground in the middle (Fig. 7).¹³

There is an interesting detail concerning the establishment that also gives a clue to how the mill could have been worked. In front of some of the tunnels, very near the precipice, is a small cone about 0.5 m high and reaching above the floor level, with a roughly rectangular surface about 0.5×0.3 m but with a wider base. There are three of these cones in total *in situ* and a fourth one has been dislocated (Fig. 6). No doubt, the water was conducted to each mill through pipes (or half-pipes) made of wood or some other material, and the cones formed the support for the ends of the pipes. The grooves which are now visible on the face of the precipice have been formed by water running outside the pipes—and the water continued to run after the pipes ceased to exist. Each pipe conducted the water to a horizontal wheel below floor level. The water caused this wheel to turn, as well as a mill-stone at a higher level which was on the same vertical axis, situated above the floor, which may have been made of wood at that point. This type of horizontal-wheeled mill, formerly called

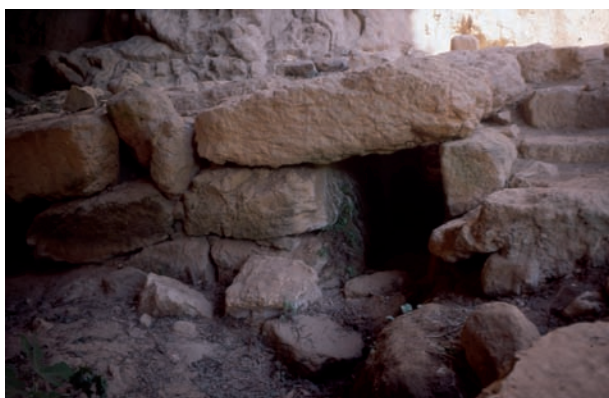
Fig. 7a and b. The two tunnel openings flanking the staircase.

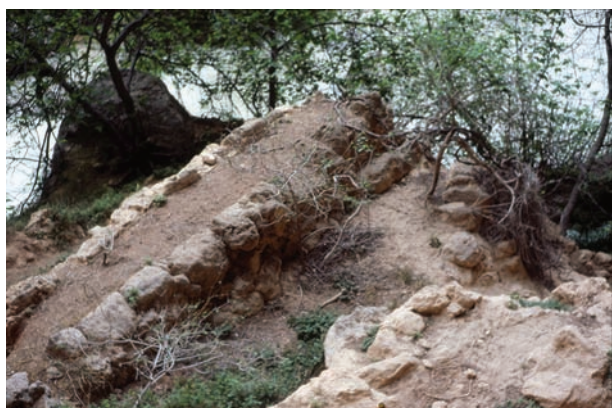
Fig. 8. Channel near the river, now cut off.

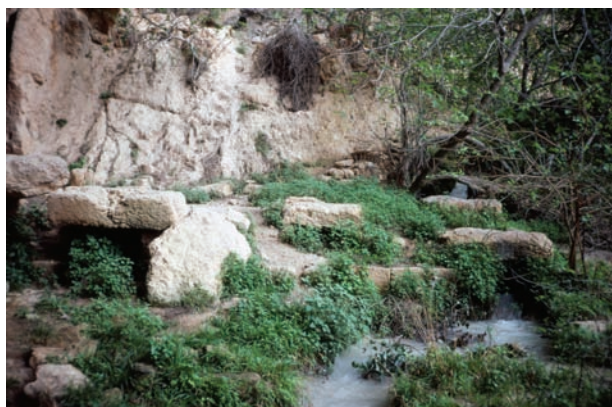
Fig. 9. Channel still containing water. To the left is one of the tunnel openings.

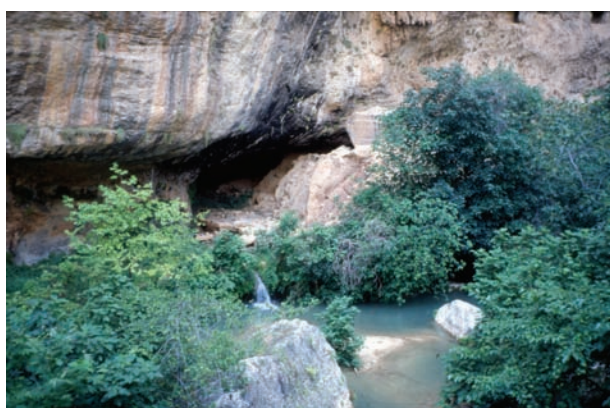
Fig. 10. View of the establishment showing water from the tail-race flowing into the river.

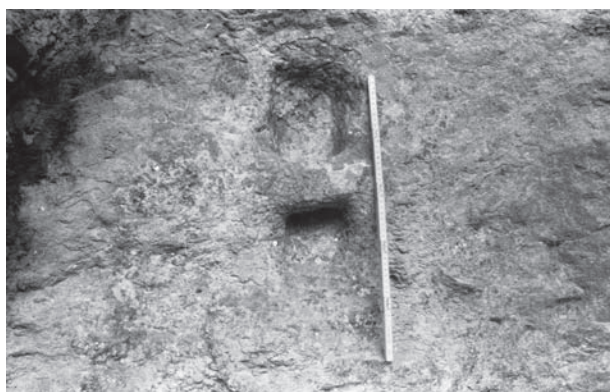
Fig. 11. Rock-cut handle for tying animals. The ruler is 50 cm.

The Austrian expedition found an interesting device along the latter channel. In the vertical rock-face above it was a series of cuttings with handles in them and beside them a short inscription consisting of a few big letters flanking a cross.¹⁸ The number of handles can be counted to seven, cut between 1 and 2 metres above ground-level, and located both vertically and horizontally (*Fig. 11*). The thickness of the handles is about 6 cm, and they are sunk into cuttings about 13 cm wide. Undoubtedly, they were used for tying draught animals during the stay at the mill, and it is obvious that the channel

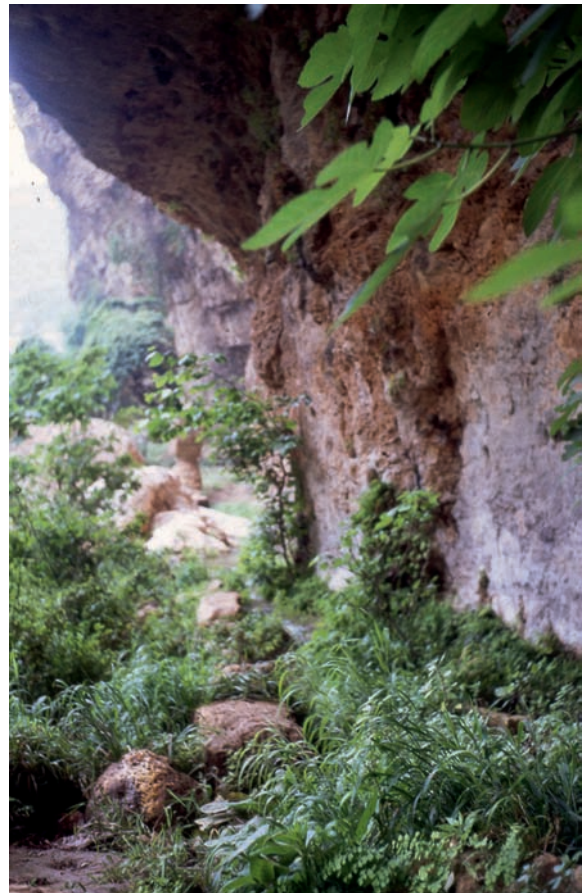
Fig. 12. Rock-face with handles and the channel lining below.

did not exist then—otherwise the animals would have been standing in the channel with their feet partly in the water, and partly on the stones of the channel lining (Fig. 12). Many of these stones have been taken from the floor of the milling establishment, another indication that the channel is of a later date.

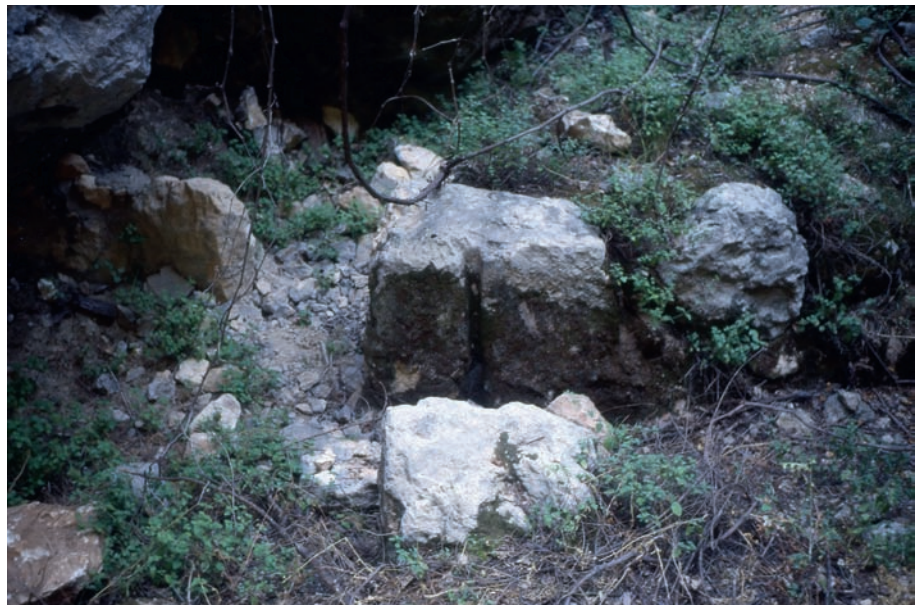
Fig. 13. Blocks forming a sluice in the establishment across the river.

lishment—as the one on the western side—but are more irregularly connected. They were also reported to have been in use in the 1940s. Part of a polygonal wall is preserved below the mills. Among the jumble of stones is a part of a rock-cut groove, 30 cm wide and 30 cm deep, with a rectangular section. Parts of other grooves are also visible, all running parallel to the river. Two sluice-stones, with slots 6 cm wide and 4 cm deep are standing opposite each other, separated by an interval of 62 cm (Fig. 13), and a third sluice-stone can also be seen, though not in situ. The task of cleaning the area would
